Ground Inspection

Structural Engineering Division

Thermography Inspections

OV-103 6L Pre Impact

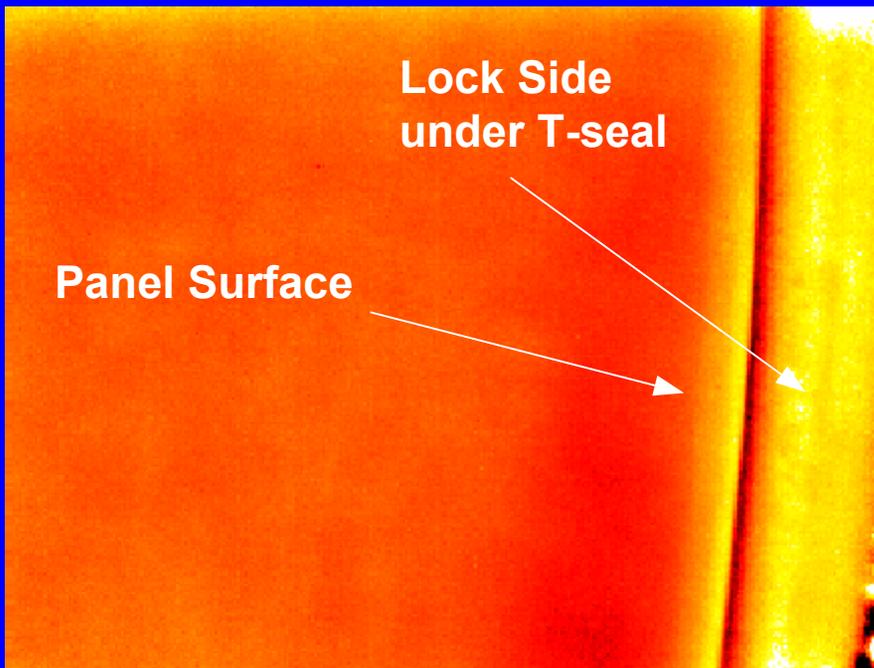
Thermal Image of the location of the crack

**Outboard
(W/out T-seal)**

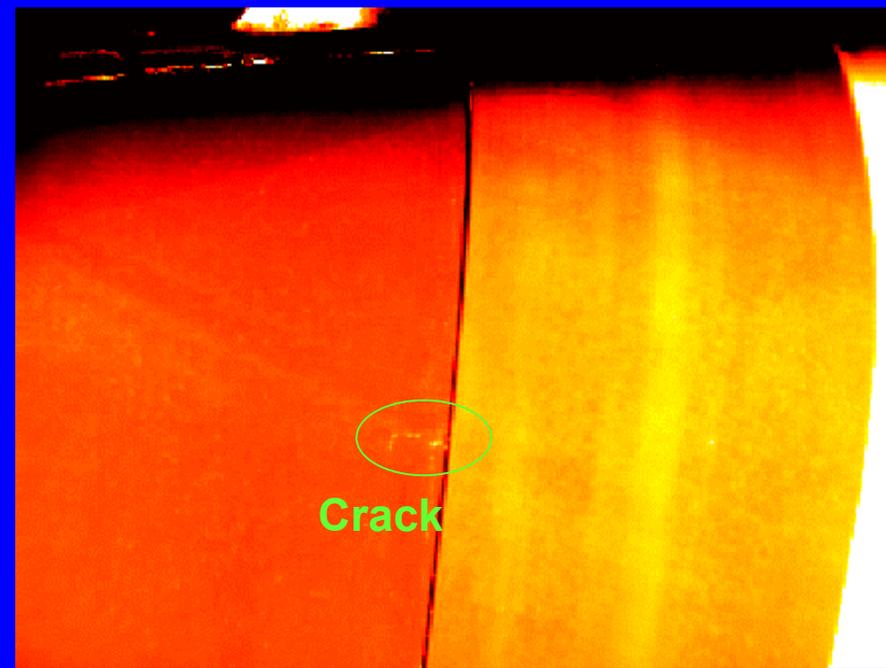
OV-103 6L Post Impact

Thermal Image of the crack through the part

**Outboard
(W/ T-seal)**

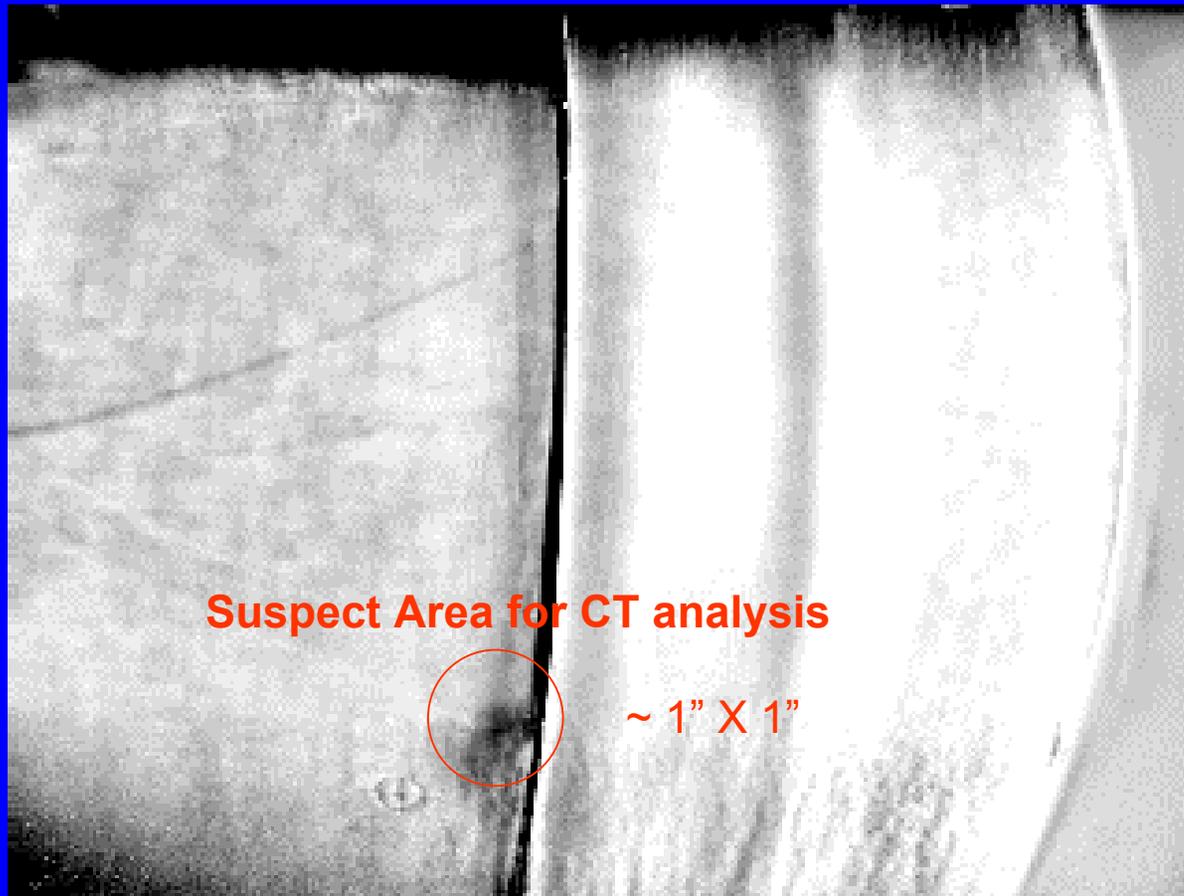
OV-103 6L Post Impact

PCA Analysis of thermal data
