NATIONAL AERONAUTICS AND SPACE ADMINISTRATION

# APOLLO 12 MISSION REPORT

MANNED SPACECRAFT CENTER

MARCH 1970

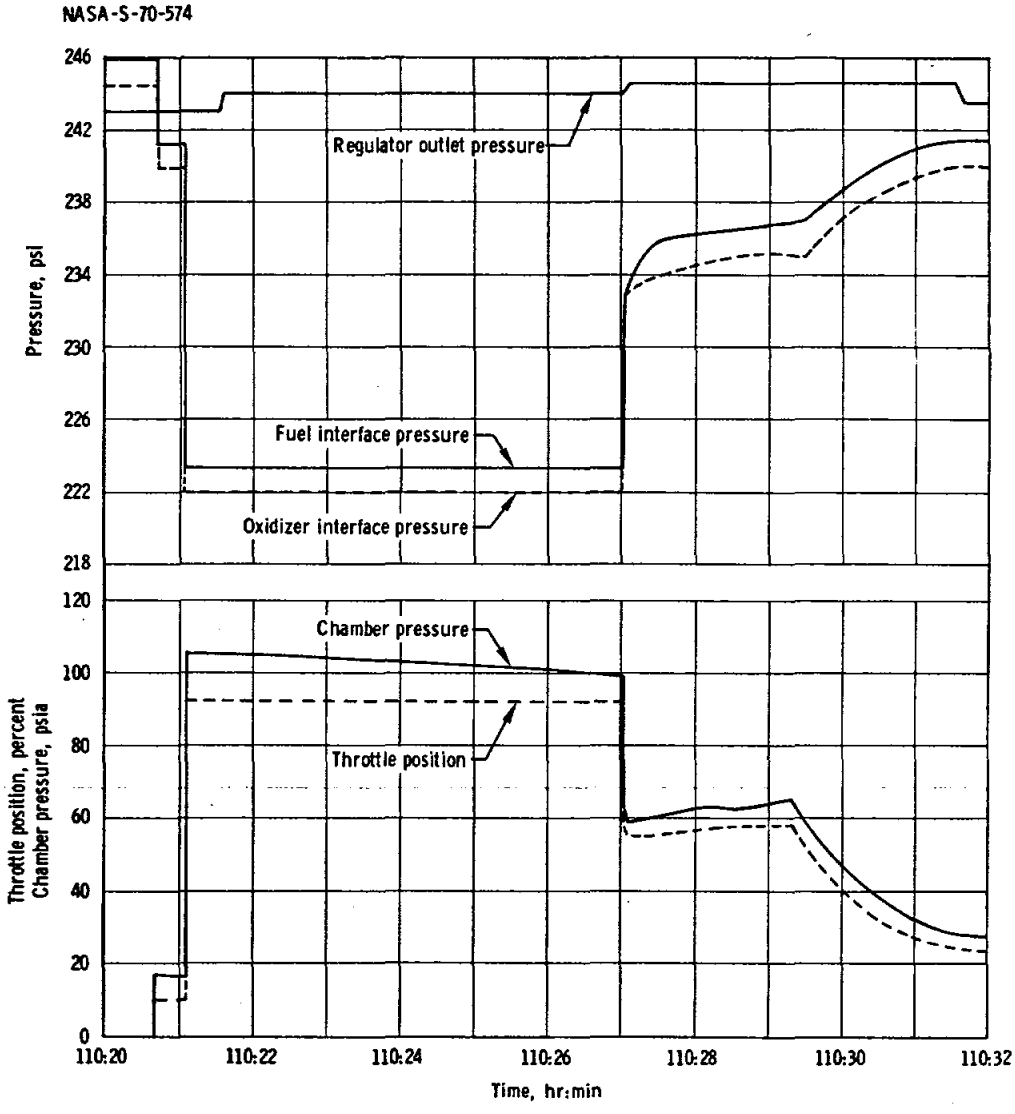
Figure 8.8-1. - Descent propulsion system performance.

The descent propulsion system performed normally during the 29-second descent orbit insertion maneuver. The powered descent firing lasted 717 seconds, and the system pressures and throttle settings are presented in figure 8.8-1. The data curve has been smoothed and does not reflect the numerous throttle changes made during the final descent. During powered descent, the oxidizer interface pressure appeared to be oscillating as much as 59 psi peak to peak. These oscillations were evident throughout the firing but were most prominent at about 55- to 60-percent throttle.

Oscillations of this type were also observed during the Apollo 11 descent. After the Apollo 11 flight, it was determined that the oscillations resulted from the instrumentation configuration and were not inherent in the system. Engine performance and operation were not affected in either flight.

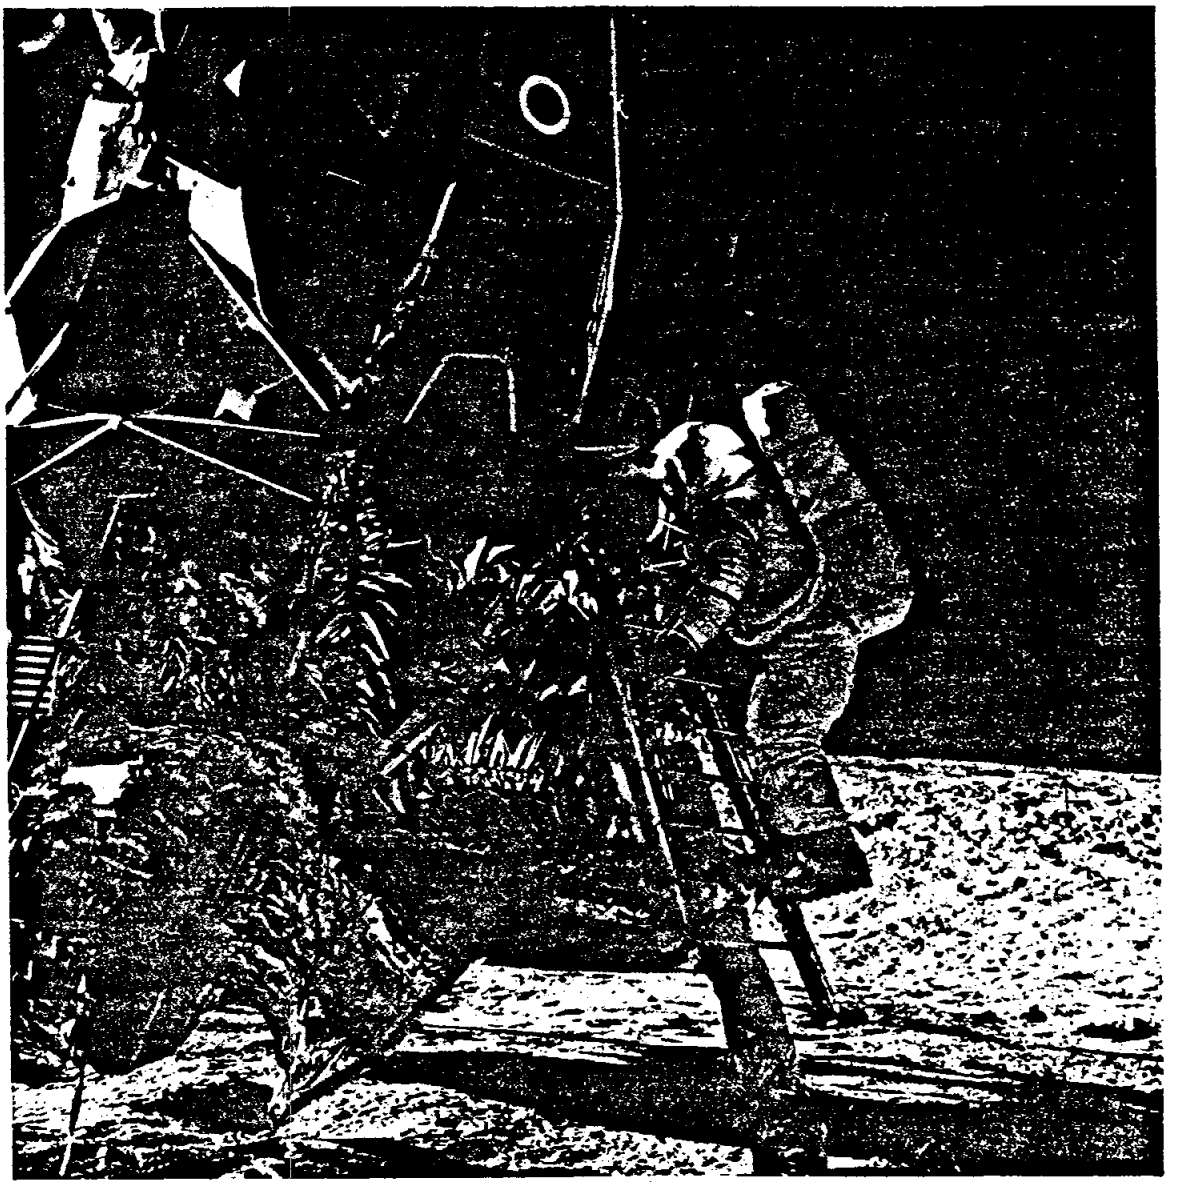
Figure 9-2.- Lunar Module Pilot descending to the lunar surface.

After the Lunar Module Pilot had egressed (fig. 9-2), he had difficulty in closing the door from the full-open to a partial position, since there is no exterior handle provided. The flap that covers the hatch lock handle cannot be reached from outside the spacecraft with the door full open, and the only other protuberance, the door covering the dump valve, is so close to the hinge line that considerable force must be used to close the door.

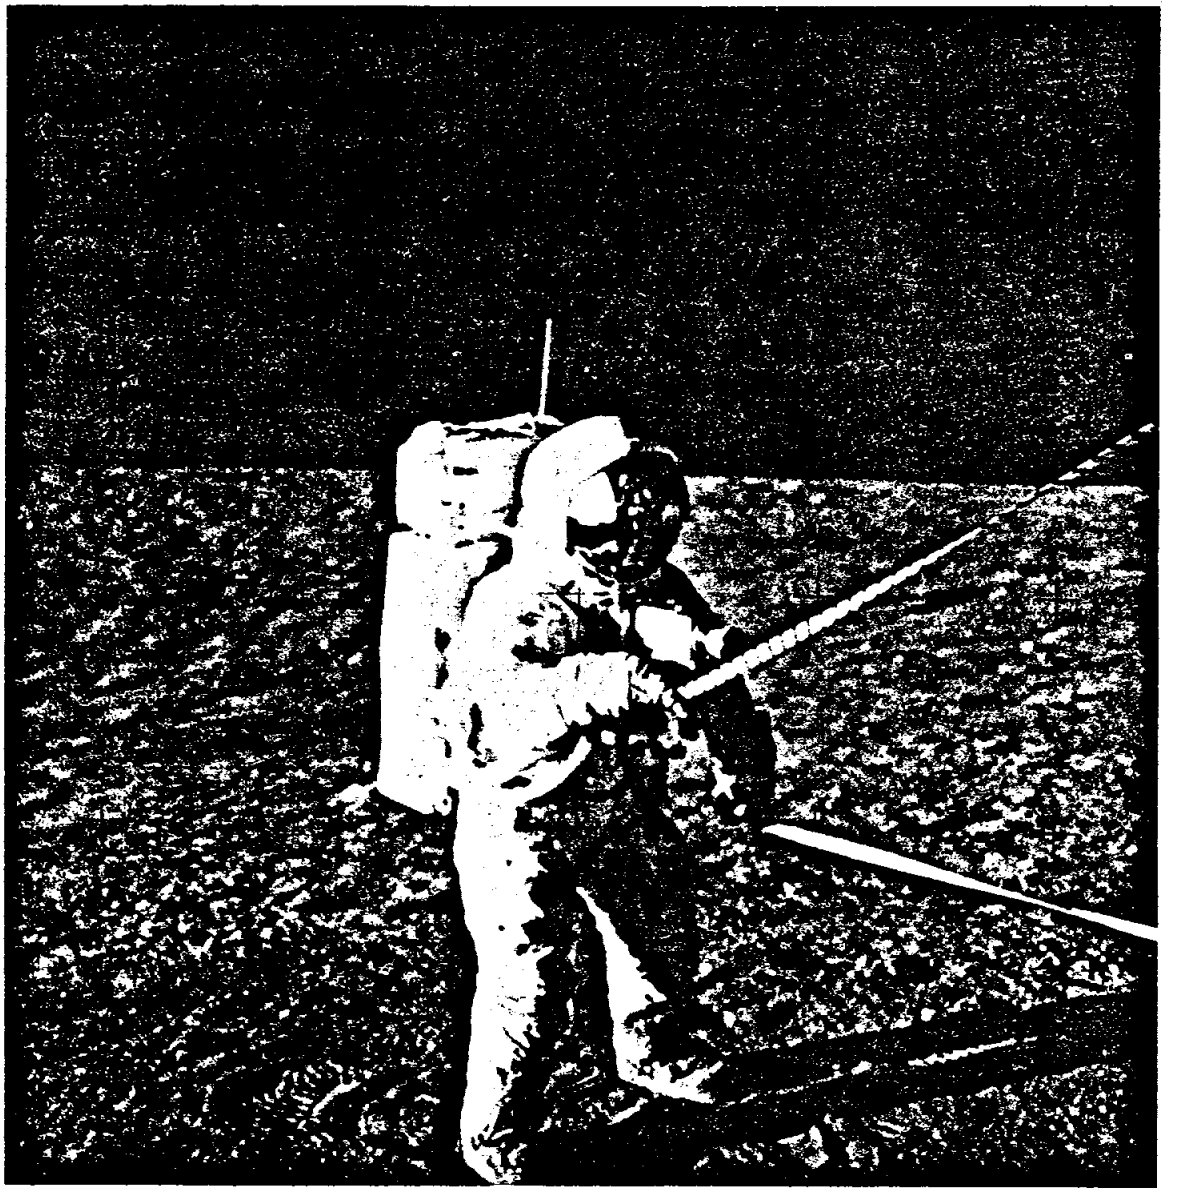
Figure 9-5.- Commander operating equipment conveyor.

The single-strap lunar surface conveyor (fig. 9-5) was easy to deploy and generally performed satisfactorily. The end of the strap resting on the surface collects dust, which is subsequently deposited on the crewmen and in the lunar module cabin. The metal pin that retains the lunar module end of the conveyor was not large enough to prevent it from slipping out of the yoke. By the end of the second extravehicular period, the lock buttons on the two hooks were extremely difficult to operate because of accumulated dust. This locking feature is not necessary.

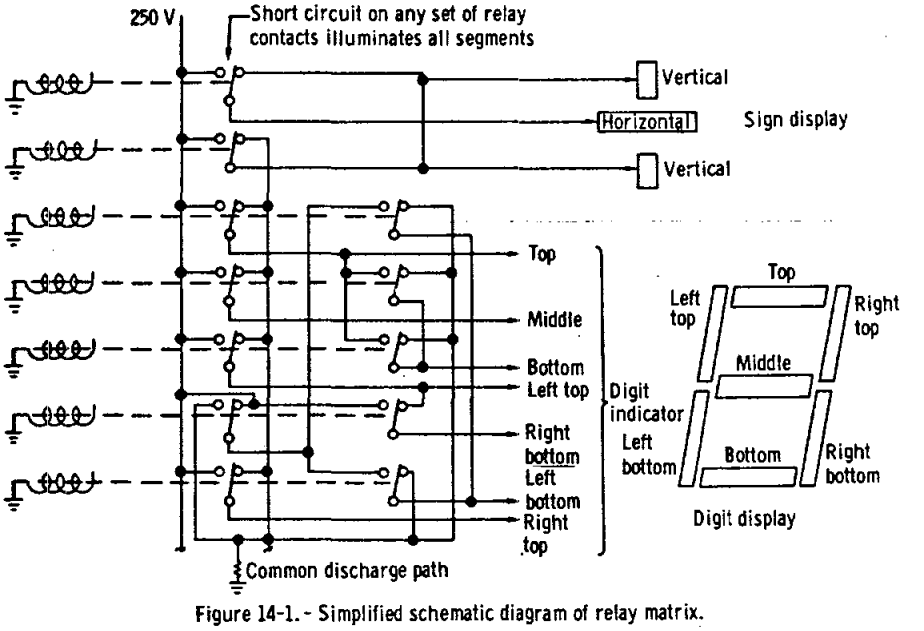
Figure 14-1.- Simplified schematic diagram of relay matrix.

The crew reported several intermittent, all-"8's" displays on the main display and keyboard assembly approximately 1-1/2 hours before launch, but no display malfunction occurred in flight. The display segments are illuminated by applying 250 V ac through the contacts of miniature relays, as shown in figure 14-1. When a segment is off, it is grounded through a resistor and the normally closed contacts of a relay to avoid residual illumination. The normally closed contacts of all relays are tied together; consequently, a short across the contacts of any one relay will apply the voltage to all segments of each display. The effect of the short in conjunction with the common discharge path is shown in figure 14-1 for a typical character and one sign. A short across the relay contacts will affect only the display function of the unit.

Failure analyses performed after four previous identical failures on other units showed that contamination was present in a relay which could have caused the all-"8's" display. As a result, the fabrication process has been improved through the use of laminar-flow clean rooms to minimize contamination. A 100-percent vibration screening procedure was initiated at the part level with automatic detection of any actuation faults. After assembly, each display keyboard is vibrated during actual operation and visually observed for fault detection. However, improved fabrication techniques and test procedures can not eliminate the possibility of contamination; consequently, a malfunction procedure has been devised to remove a shorted condition through the actuation of all relays.

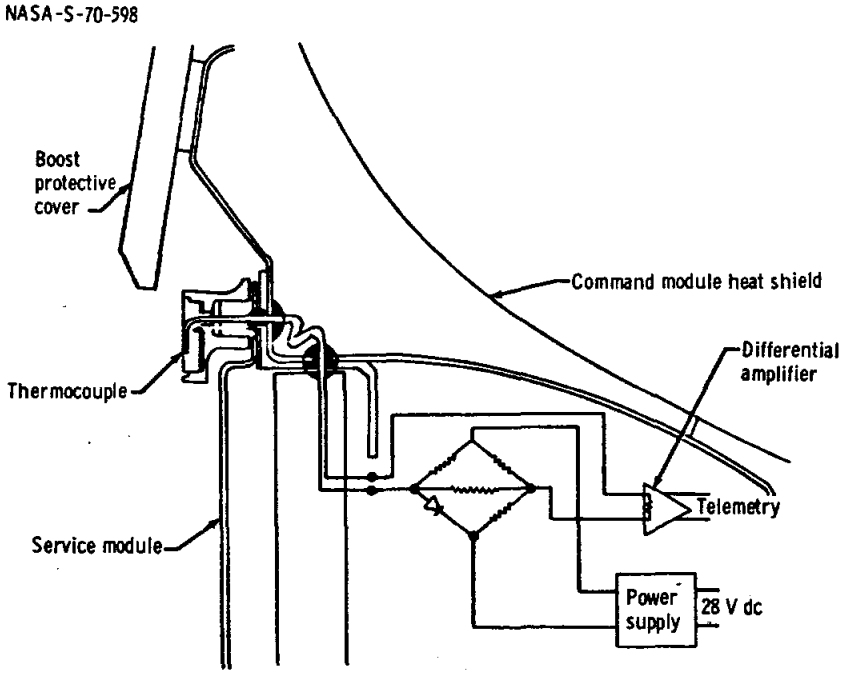
The service module outer surface temperature measurements use a chromel-constantan thermocouple and a reference junction. The reference junction is a bridge made up of three resistors and a temperature-sensitive diode (fig. 14-3). The resistors normally operate at about 0.020 ampere and will open in the region of 0.100 ampere. An open bridge resistor would drive the signal output off-scale high or low depending upon which resistor fails.

Figure 14-3. - Simplified schematic and location of a typical outer skin temperature sensor.

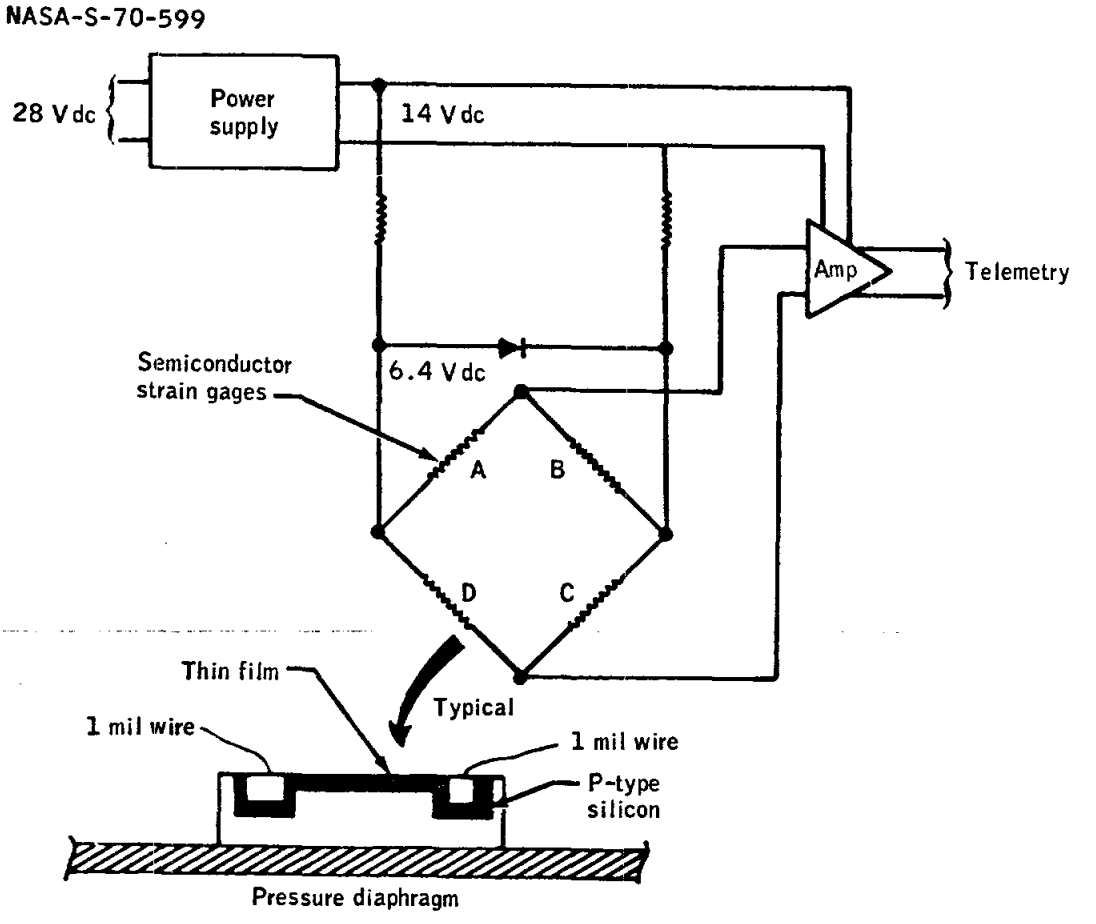
The reaction control propellant quantity measurements use semiconductor strain gages on a pressure-sensitive diaphragm (fig. 14-4). The semiconductors are a thin film type, and excessive current would probably damage their capability to operate as pressure-sensitive resistors. An alternate possibility is that the Zener diode, used to regulate the 14-volt supply to 6.4 volts, was burned out. Loss of this diode would explain the instrumentation symptom, which in all four cases was full-scale and unchanging.

Figure 14-4.- Propellant quantity transducer schematic.

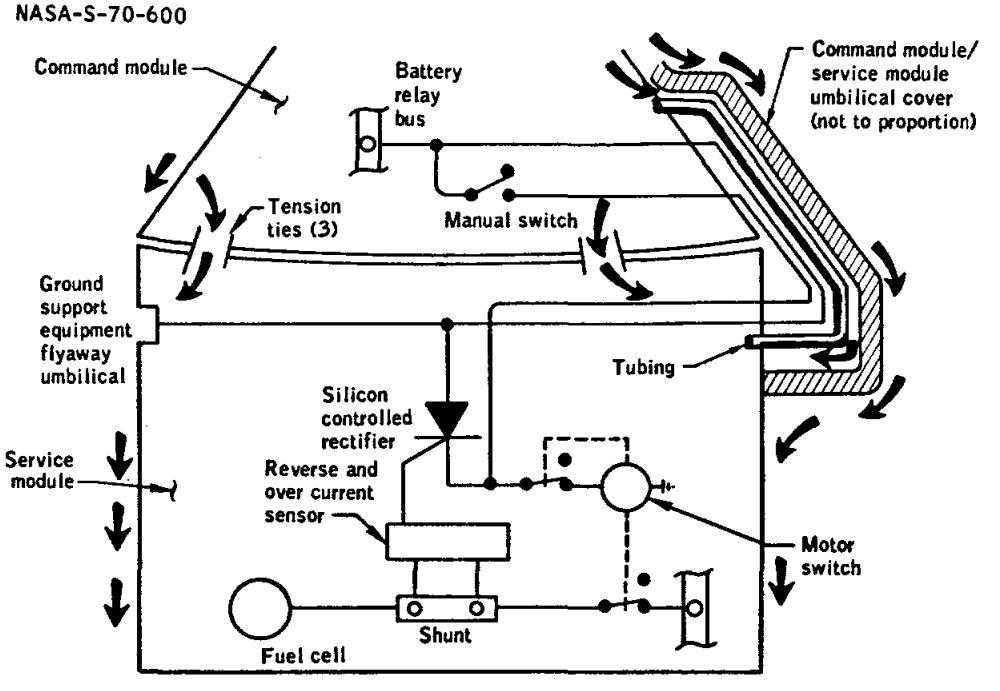
The voltage transient that was induced on the battery relay bus by the static discharge exceeded the current rate-of-change characteristics of the silicon controlled rectifiers in the fuel cell overload sensors and disconnected the fuel cells from the bus (fig. 14-5). As a result, the main bus loads of 75 amperes were being supplied totally by entry batteries A and B, and the main bus voltages dropped momentarily to approximately 18 or 19 volts, but recovered to 23 or 24 volts within a few milliseconds. The low dc voltage on the main buses resulted in the illumination of undervoltage warning lights, a drop out of the signal conditioning equipment, and a lower voltage input to the inverters. The momentary low-voltage input to the inverters resulted in a low output voltage which tripped the ac undervoltage sensor causing the ac bus 1 fail light to illuminate. The transient that disconnected the fuel cells from the buses also caused the silicon controlled rectifier in the overload circuits to indicate an ac overload. At 2 minutes 22 seconds into the flight, the crew restored fuel cell power to the buses. All bus voltages remained normal throughout the remainder of the flight.

Figure 14-5.- Fuel cell disconnection circuitry.

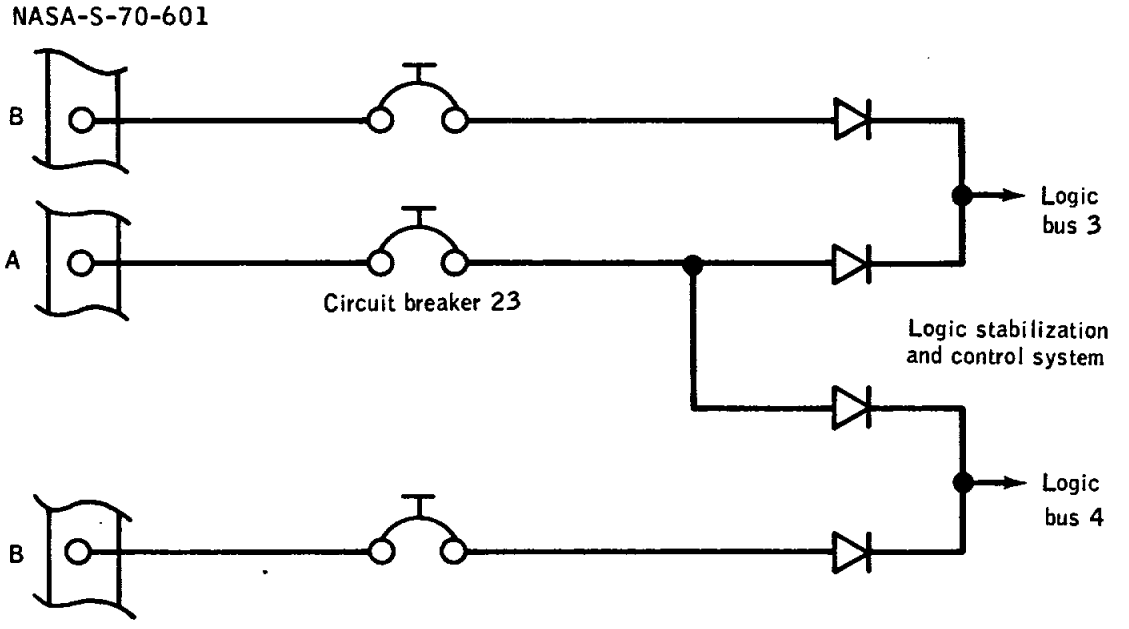
it remained closed throughout the rest of the mission. Complete electrical and mechanical tests were performed and the results were normal. The circuit breaker and associated circuitry showed no cause for the breaker to have opened either because of launch vibrations or an electrical fault.

Figure 14-6.- Stabilization and control circuit breaker schematic.

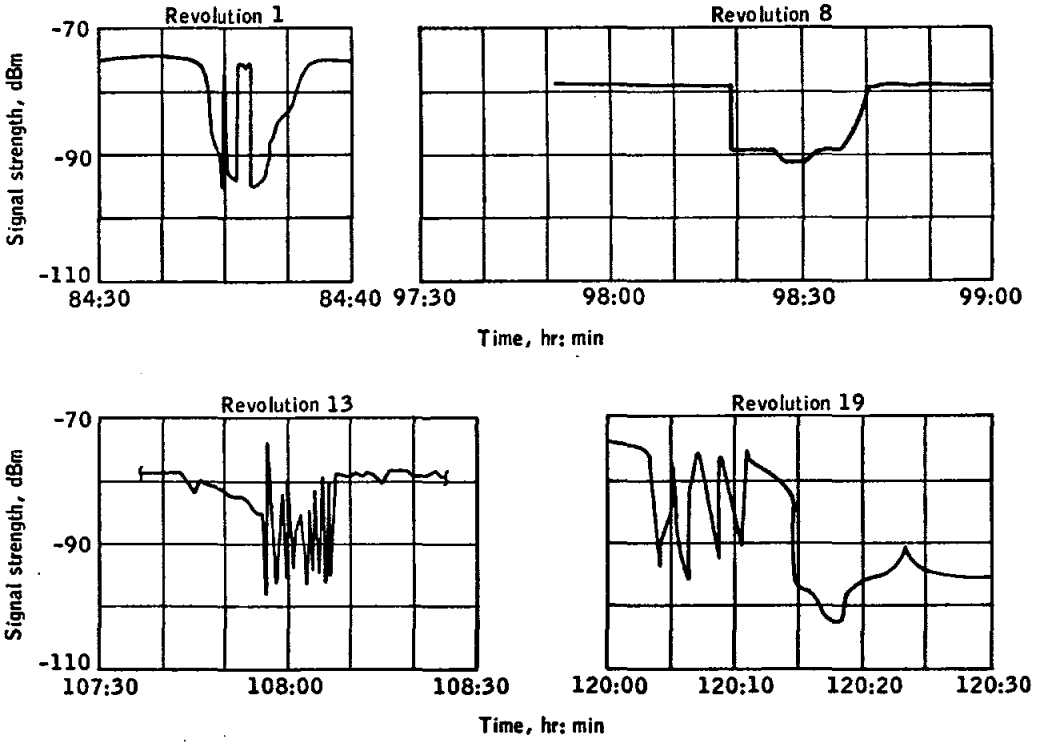
Figure 14-7.- Typical high gain antenna uplink signal strengths during abnormal operations.

Operation of the S-band high gain antenna in the narrow beam mode resulted in a decrease of approximately 10 to 12 dB in both uplink and downlink signal strength on several occasions. Illustrations of the first and other unexpected signal-strength variations are shown in figure 14-7. The first decrease occurred in lunar orbit revolution 1.

Two special tests were conducted during transearth coast with the spacecraft in attitude hold to isolate the malfunction. The sun angle was within approximately a 12-degree cone about the minus X axis to induce thermal stress on the antenna. In both tests, the narrow-beam and reacquisition modes were maintained until fluctuations in the uplink and

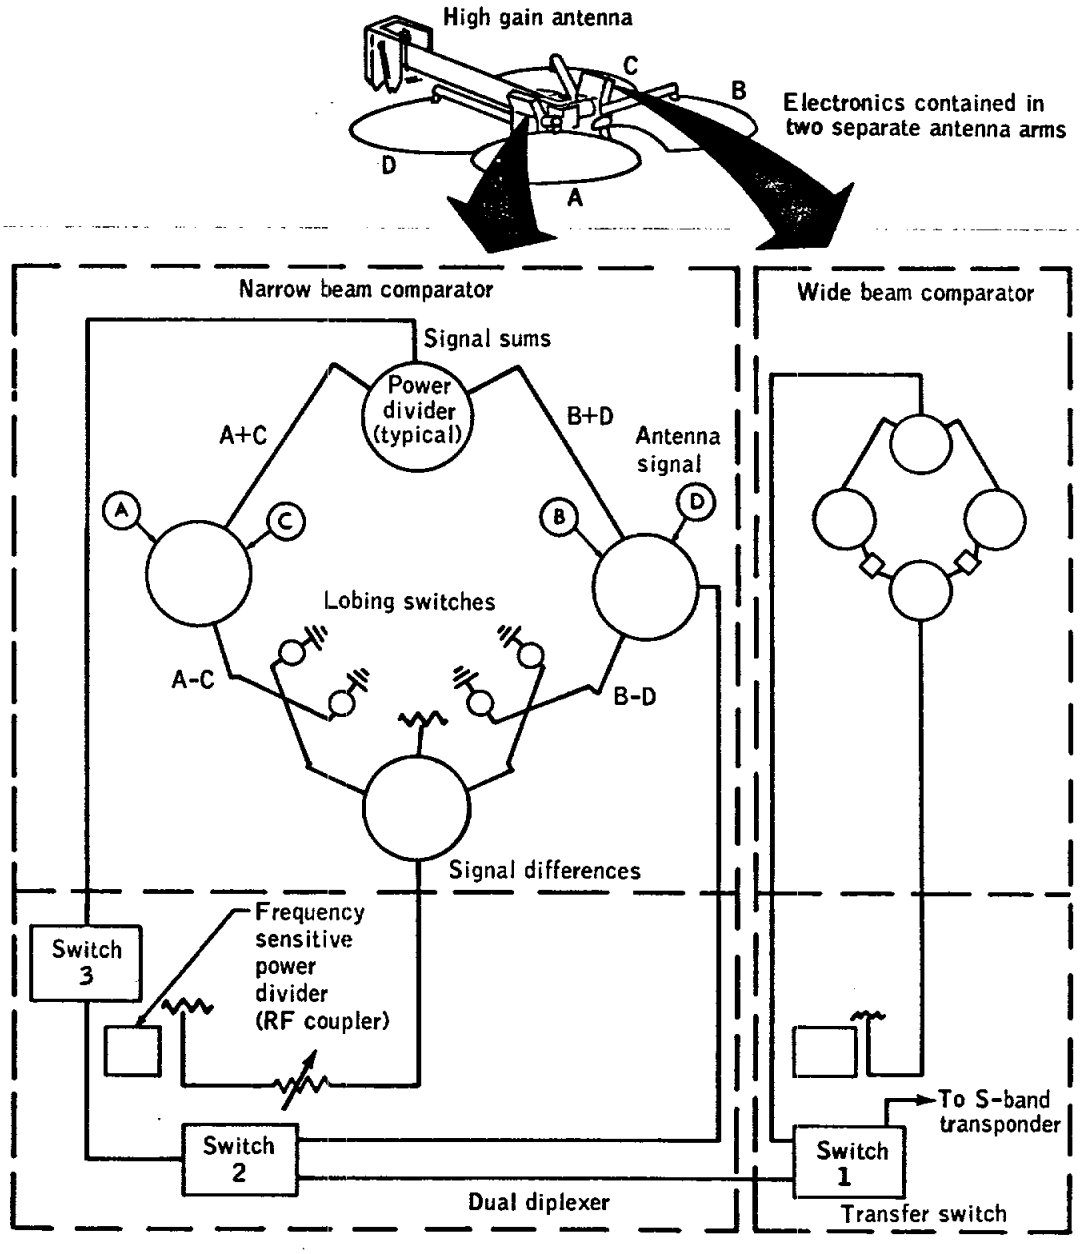
The narrow beam comparator combines the patterns of four dish antennas to provide the sum and difference patterns which provide the angle pointing information. Two malfunctions that could produce boresight shifts have been identified in the narrow beam comparator. Under normal operating conditions, the lobing switches function as digital phase shifters and provide either a zero or 180-degree phase shift. If a diode fault occurs that changes the phase or amplitude characteristics of either switch, tracking errors can be produced. The opening of one set of diodes would have to be intermittent to produce the observed flight anomaly, thus suggesting the presence of temperature or pressure sensitive connections in the traces that connect the diode switches. Another diode fault which can occur is a loss of the drive voltage to one of the lobing switches. In this case, the switch will provide a constant phase shift. The multiplexed difference signal for the case when the phase shift of switch 1 (fig. 14-8) is constant at 180 degrees results in unsymmetrical lobing. The antenna, in this case, will seek those pointing angles that make the elevation and azimuth angles equal in magnitude, thus suggesting that the resultant tracking error could be large and not repeatable. This condition would give the observed antenna performance characteristics. Therefore, a malfunction in the diode wiring or circuit connections is suggested. The intermittence associated with this malfunction could be explained by a temperature sensitive circuit connection (solder crack or wire break).

Figure 14-8.- S-band high gain antenna electronics.

Malfunctions in the dual diplexer or narrow beam comparator are considered to have the highest probability as causes of the anomaly. New phase-III striplines, which should eliminate the problem, will be used on Apollo 13 and subsequent spacecraft.

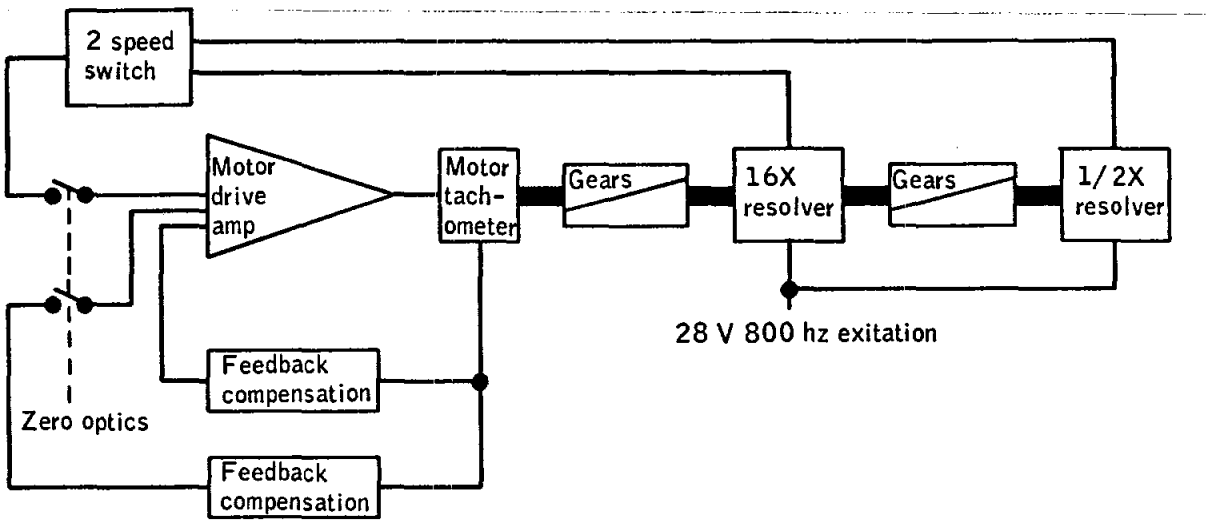
Figure 14-11.- Zero optics mode circuitry.

The computer register which contains the angular position of the optics shaft was observed to fluctuate as much as 0.7 degree when the system was placed in the zero optics mode. The crew reported that the shaft mechanical readout on the optics also reflected the fluctuation.

A number of components in the optics drive servomechanism (fig. 14-11) are used only in the zero optics mode. The optical unit and the power-and-servo assembly were removed from the spacecraft, and the servo assembly was subjected to thorough testing. The flight symptoms, however, could not be reproduced. Because of extensive sea-water corrosion, the optical unit could not be tested, but an analysis and testing of a similar unit demonstrated the cause of the zero optics anomaly to be within the power-and-servo assembly. The flight assembly was installed in a working system and has operated properly under a variety of thermal conditions. The modules associated with the optics servo were also thermally cycled in an oven, operated in a vacuum, and subjected to acceptance test vibration levels with no degradation of their performance. The modules were depotted and examined, but no cause of the anomaly could be isolated.

Analysis of the circuitry involved in the zero optics mode has isolated the problem to either a relay module, a two-speed switch module, or the motor drive amplifier module. Of these, the motor drive amplifier module is the most likely cause of the anomaly observed, since it contains the only active signal-shaping network. The inflight symptoms have been reproduced on a breadboard mockup of the system by introducing a noise of from 600 to 800 millivolts into the in-phase carrier. A number

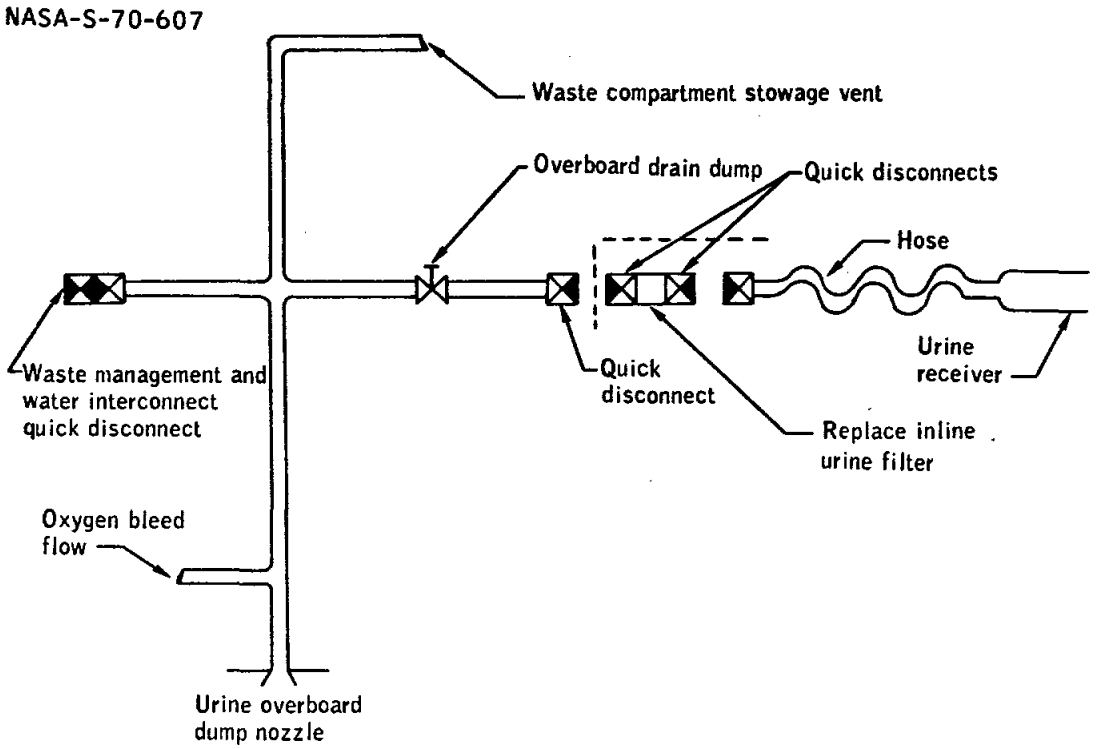
By about 215 hours, the crew reported that both urine filters had clogged and that the urine overboard dump system was being operated without a filter. The inline filter (fig. 14-12) clogged the day after the Commander and the Lunar Module Pilot returned to the command module from the lunar surface activity (day 7). The filter was then replaced by a spare unit which also clogged 2 days later. The urine dumping system operated satisfactorily without a filter for the remainder of the mission (approximately 30 hours).

Figure 14-12.- Urine dump system flow schematic.

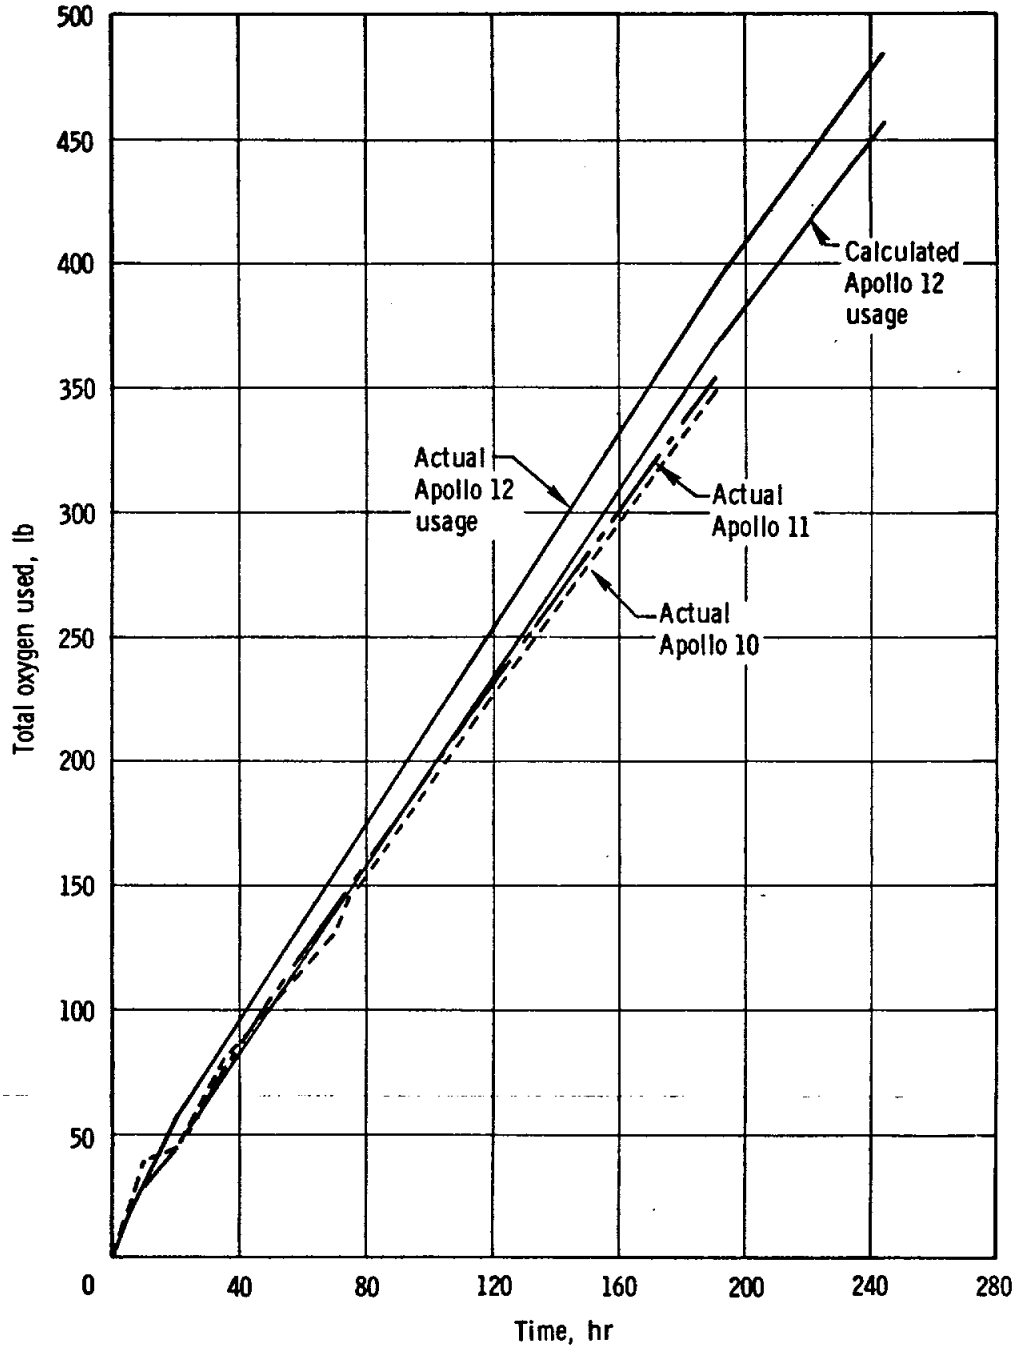
At the end of the mission there was a discrepancy of approximately 27 pounds of oxygen between the measured total cryogenic oxygen usage and the calculated combined environmental control system and fuel cell oxygen usage, as shown in figure 14-9.

Postflight leak tests were conducted on the command module 900-psi system, including all check valves. These tests indicated that system leakages were within specification limits. It is therefore concluded that the 27 pounds of oxygen must have leaked from those portions of the 900-psi system within the service module. Tests of these systems prior to flight are considered adequate, and no corrective action is required.

Figure 14-9. - Comparison of oxygen consumption for Apollo 10, 11, and 12.

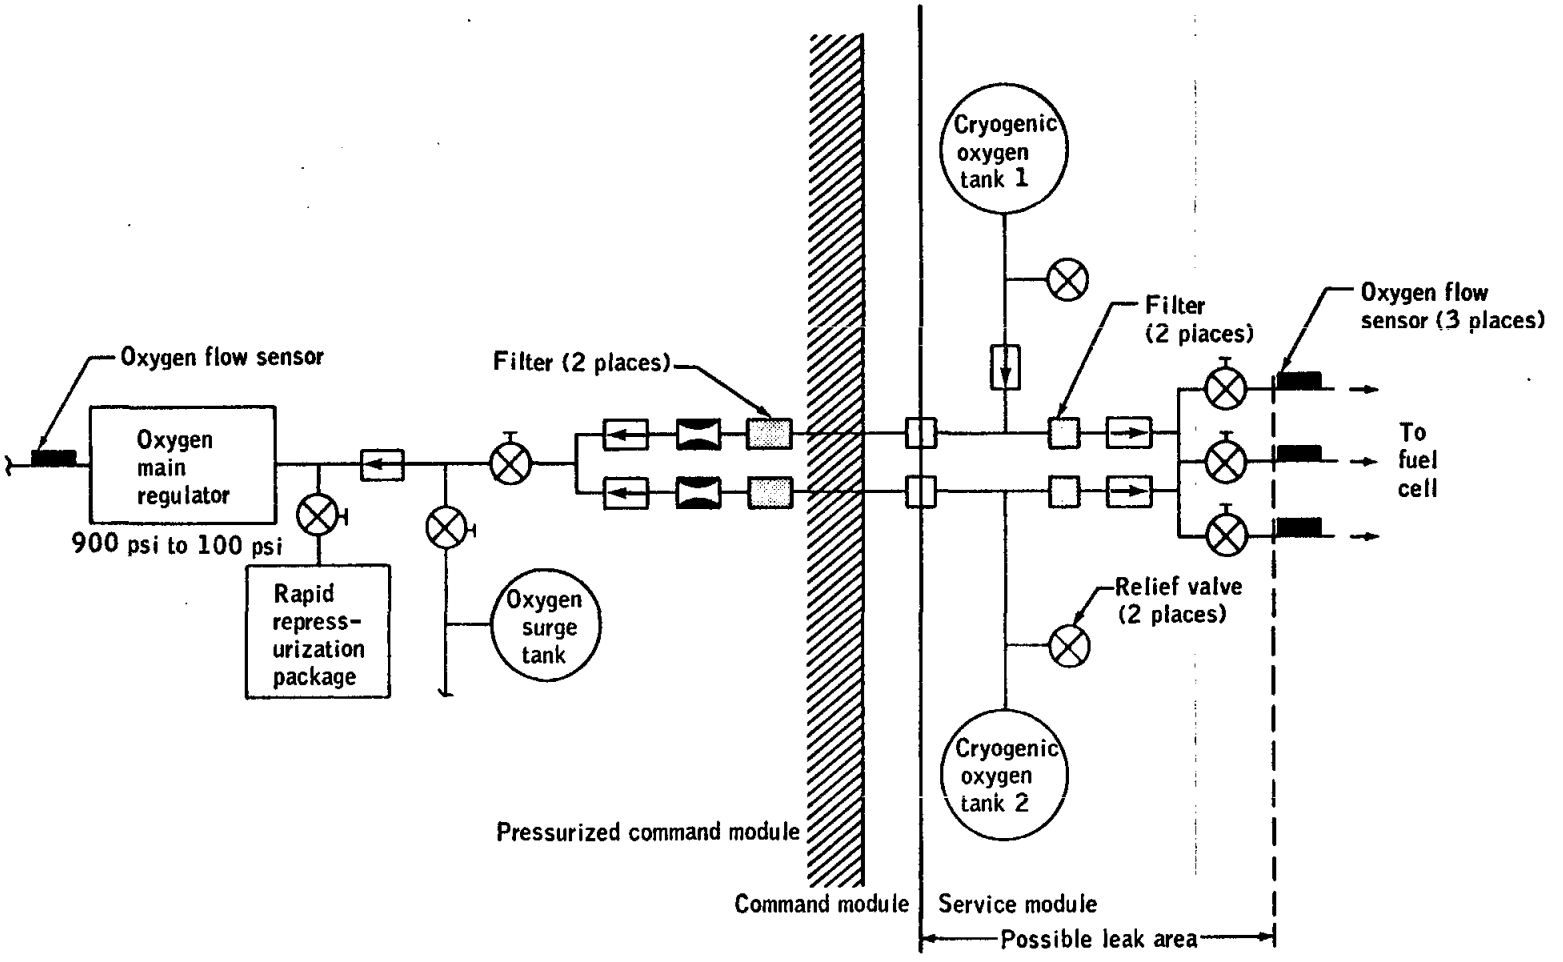
Fuel cell oxygen usage was calculated from the produced electrical current and then verified by comparison with hydrogen consumption data. Environmental control system usage is measured on a flowmeter and compared with calculated usage based on purge rates, cabin leakage rates, metabolic consumption and urine dump losses. Cabin leak rates are determined by ground tests in conjunction with flight pressure decay rates. Purge rates are calculated based on ground tests and known times for purges. Oxygen losses during urine dump operations can only be estimated. Since no excessive flow was detected downstream of the flowmeter, the source of any command module environmental control system leakage is therefore limited to the 900-psi system upstream of the meter. Figure 14-10 shows the 900-psi oxygen system and that portion of the system outside the command module that could have leaked.

Figure 14-10.- Schematic of 900 psi oxygen system.

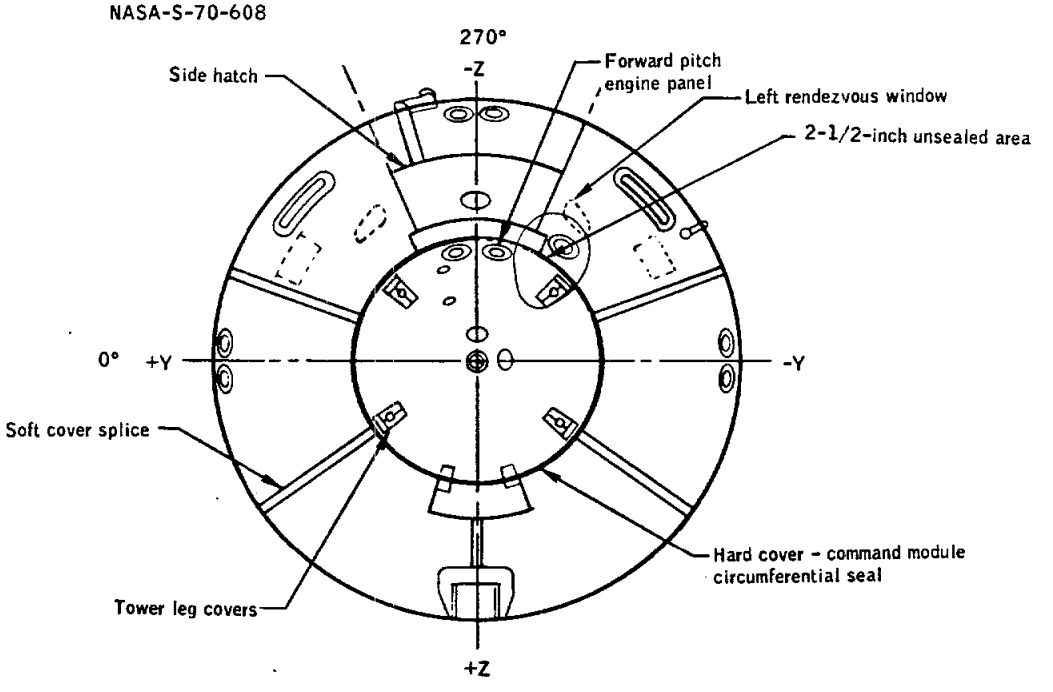
The hatch, left-hand side, and both rendezvous windows of the command module had considerable amounts of contamination appearing as vertical streaks on the exterior surfaces. Before flight, gaps in the boost protective cover were noted in the hard-to-soft transition region over the left rendezvous window (fig. 14-13). A procedure requires that these gaps be sealed with a composition sealant on final installation of the boost protective cover; however, some gaps were not sealed. The crew reported that during the heavy rain just prior to launch they saw water on the exterior window surfaces and also observed water flowing over the windows at tower jettison. The water rivulets acted as collection sites for the exhaust residue during escape motor firing. After the water evaporated, the residue deposits remained on the surfaces of the windows.

Figure 14-13.- Boost protective cover view looking aft.

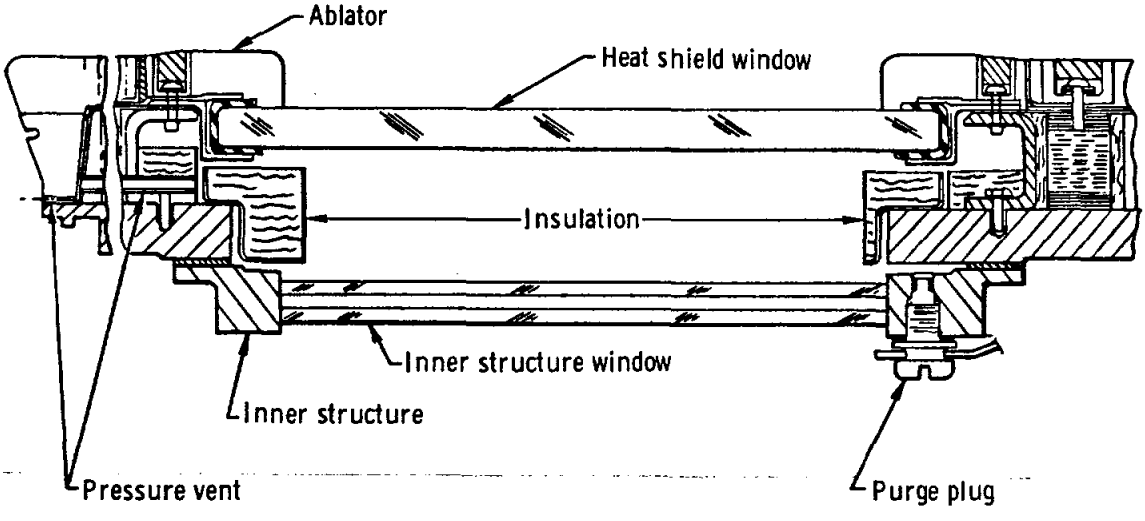
Contamination was also noted on the inside surface of the heat-shield panes on the left-hand side and hatch windows. The contamination, which disappeared on the left-hand side window after the first day, probably resulted from water entrapped between the heat shield and pressure structure in the general area of this window. The contamination on the inside surface of the hatch heat shield window remained throughout the flight and varied in size with the thermal cycles of the spacecraft. This contamination could have resulted from either entrapped moisture in the hatch area between the heat shield and the pressure structure or from outgassing of sealant materials in this area (fig. 14-14). Such outgassing has been minimal in the past three flights because the curing processes were changed to alleviate this problem. However, a chemical analysis of the contamination on the inside surface of the hatch window has shown the concentration of silicone oils to be higher than expected. These oils are the outgassed products from the material used to seal the thermal blankets near the window.

Figure 14-14. - Cross section of hatch window.

For Apollo 13 and subsequent spacecraft, seals will be added to the boost protective cover to prevent leakage of rain water. Prior to flight, the hatch window cavity will be purged with a 35/65-percent mixture of dry nitrogen and oxygen to remove entrapped moisture. To further alleviate the outgassing of silicone oils, the insulation material will be removed from between the outer and inner hatch windows on future spacecraft.

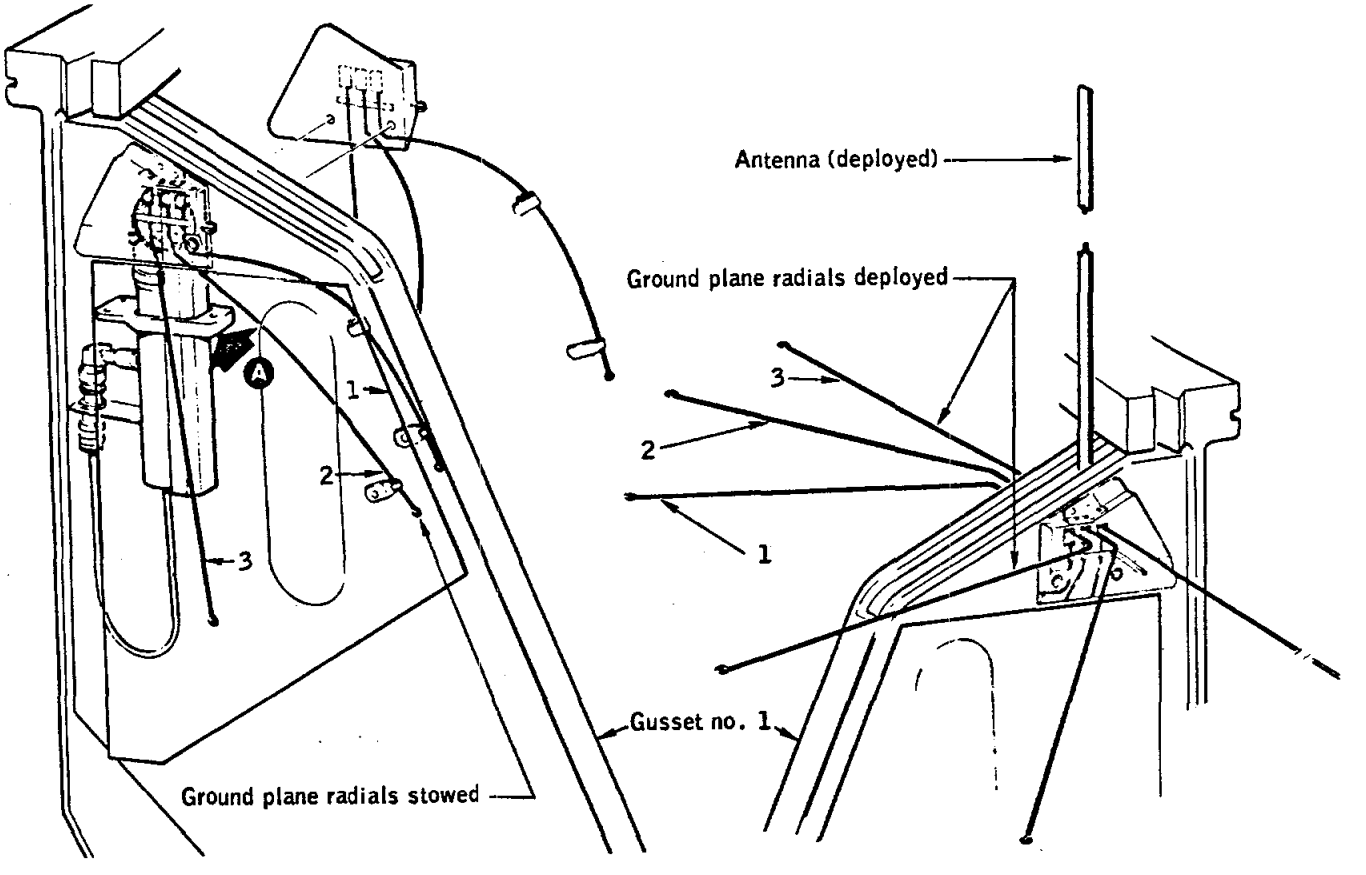
During the command module descent on the main parachutes, ground plane radials 1 and 3 of VHF recovery antenna 2 (fig. 14-15) did not properly deploy. However, voice communications with the recovery forces while using this antenna were not significantly affected. Postflight examination of the antenna revealed that the cloth flap which normally covers the radials to prevent entanglement with the parachutes could be made to stick to the gusset by an adhesive substance which was inadvertently present on both the flap and the gusset. The radials would not deploy when the flap had stuck to the gusset; however, radial 1 would not always deploy, even when the flap was not stuck. A slight binding at the spring end or at the retaining clip has been experienced on radial 1.

Figure 14-15.- VHF recovery antenna configuration.

For Apollo 13 and subsequent missions, recovery antenna 2 will be used for recovery beacon transmissions instead of voice. However, even

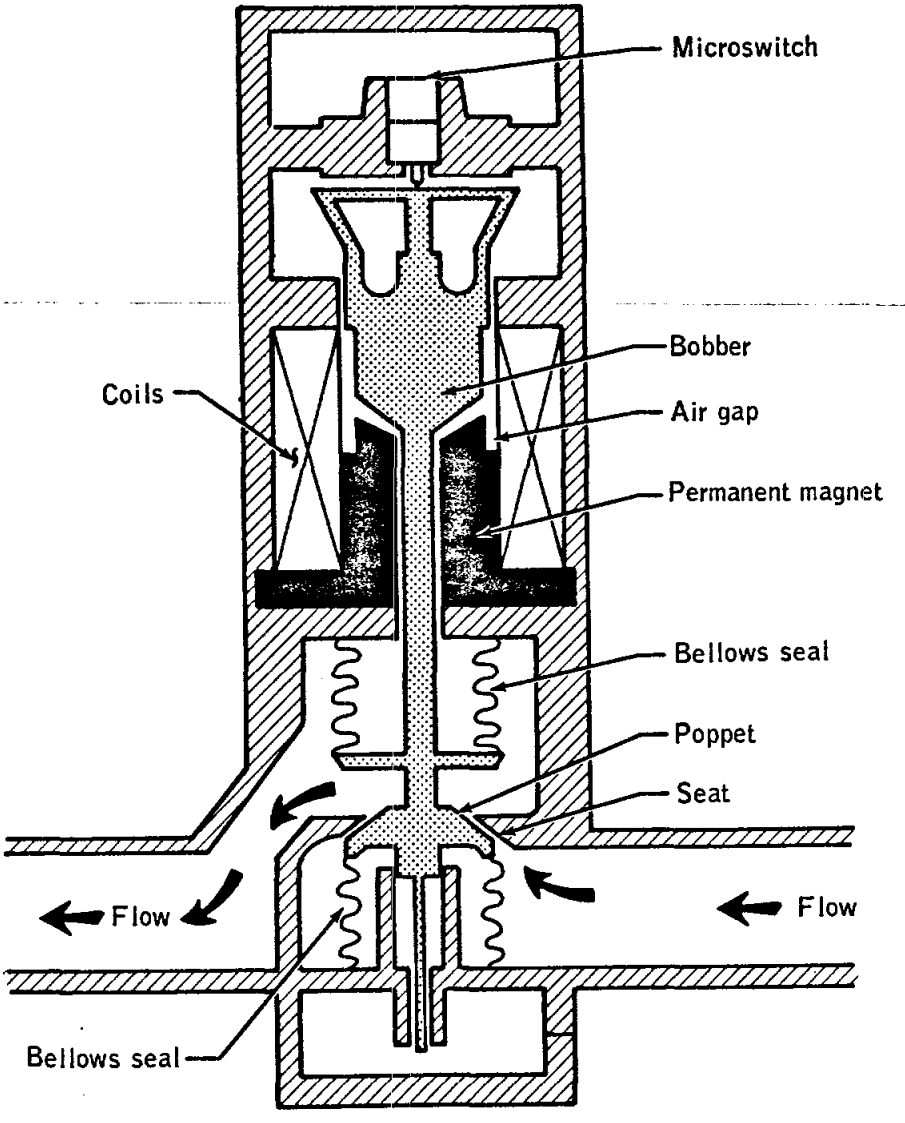
During the postflight decontamination of the command module reaction control system, the system 1 oxidizer isolation valve would not remain in the closed position; however, the valve responded normally to open and close commands. This failure to remain in the closed position has been experienced when the valve bellows are distorted or damaged. The bellows hold the valve poppet in the closed position against the pull of a permanent magnet, which is used to hold the valve poppet in the open position (fig. 14-16). A damaged bellows cannot exert enough force to hold the poppet closed. Note that the valve can be held closed by applying power to the closing electromagnetic coil.

When the oxidizer isolation valve was disassembled after flight, the inlet-side bellows had been deformed enough to prevent the valve from staying in the closed position. The bellows in the system 1 propellant

Figure 14-16.- Cross sectional view of reaction control system isolation valve.

isolation valve had also been deformed, but not enough to prevent the valve from staying closed. A review of the test and checkout history, as well as inspection records, for the Apollo 12 isolation valves indicates the valves were not degraded prior to flight. The necessity for having the valves open prior to system activation and purging will be emphasized to future crews.
