NATIONAL AERONAUTICS AND SPACE ADMINISTRATION

# APOLLO 12 MISSION REPORT

MANNED SPACECRAFT CENTER

MARCH 1970

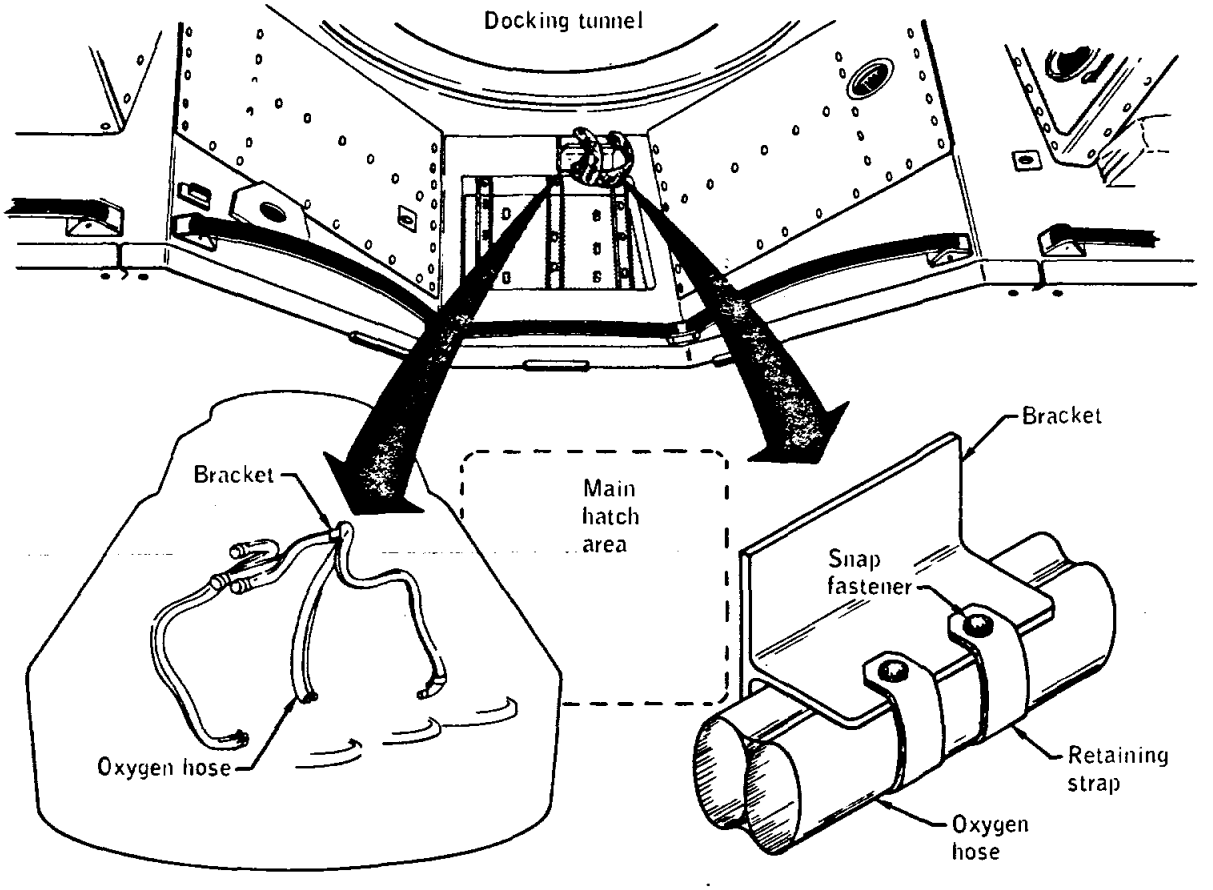
At earth landing, an aluminum retention bracket for the oxygen hoses pulled loose from the main display panel (fig. 14-17). The bracket is bonded to the panel and supports four oxygen hoses, which are attached to the bracket by Beta cloth straps that snap to the panel.

Postflight inspection of the bracket revealed an inadequate adhesion area between the bracket and the panel. The adhesive material was not uniformly spread under the bracket, thereby creating large voids. A non-uniform application of pressure during the cure cycle is the most probable cause of this condition. Manufacturing requirements have been changed to include torque testing of the bracket to assure that a proper bond has been achieved.

Figure 14-17.- Oxygen hose retention bracket.

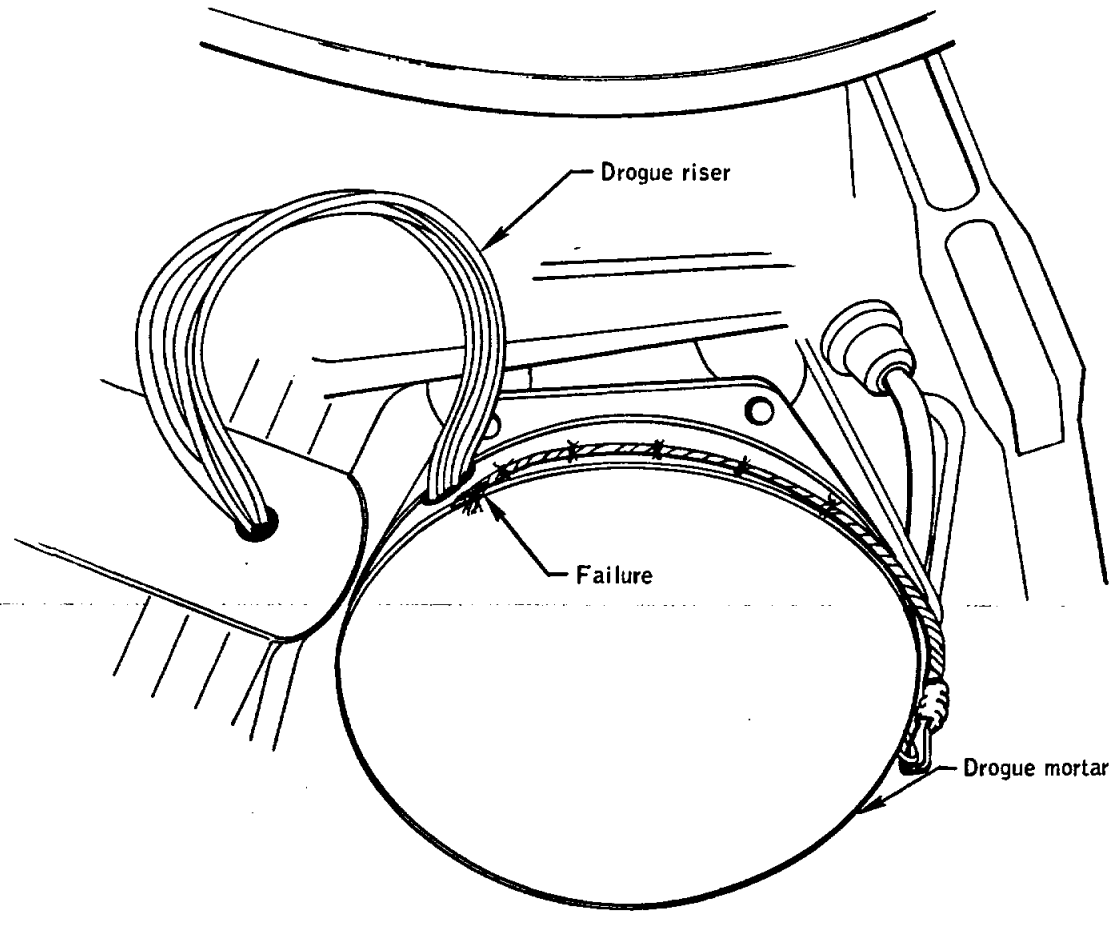
Figure 14-20.- Failed lanyard at right-hand drogue mortar.

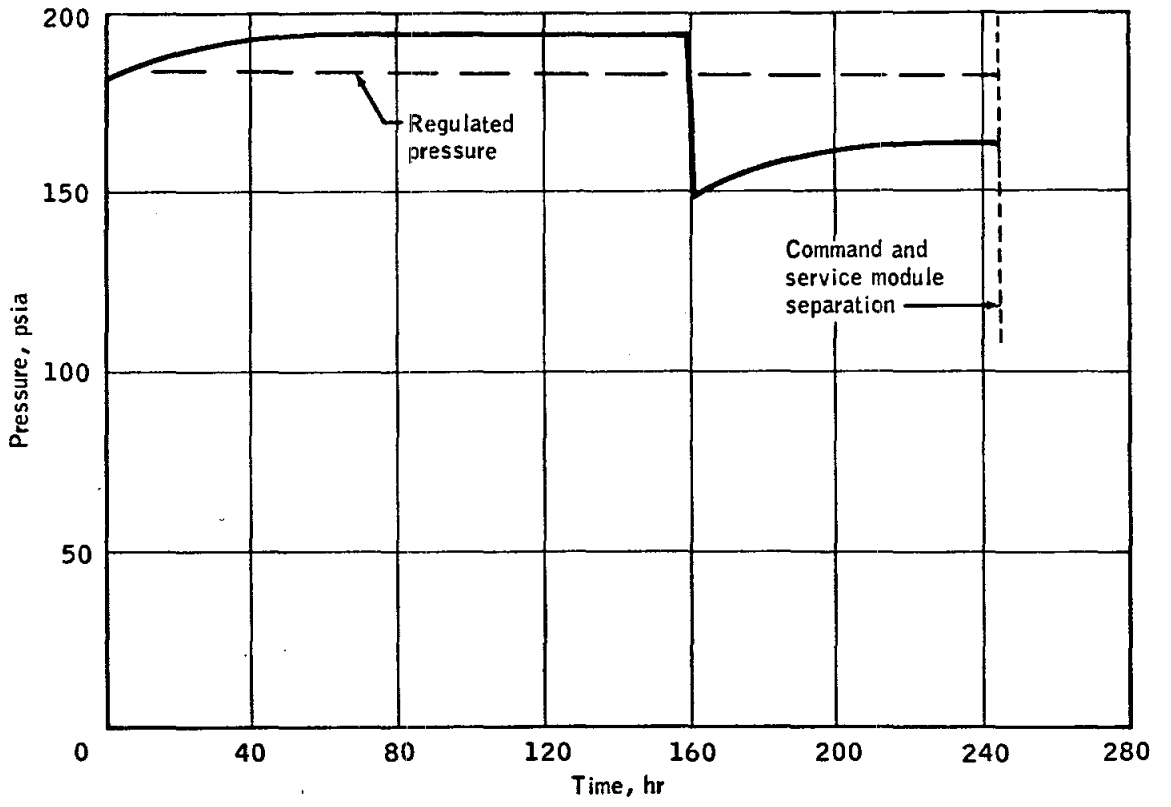
Shift in quad D helium manifold pressure.- The measurement for reaction control quad D helium pressure indicated erroneous values throughout the flight. During the first 70 hours, the pressure exhibited a slow drift of about 14 psia upward. At approximately 160 hours, the measurement then shifted from 192 to 150 psia, followed by a second slow drift upward (fig. 14-21). Both the slow drifts upward and the jump shown on the figure tend to support the conclusion that the strain-gage bonding had weakened. The measurement is primarily used during preflight testing to indicate the helium manifold pressure downstream of parallel redundant pressure regulators and is not necessary for flight.

Figure 14-21.- Quad D helium manifold pressure.

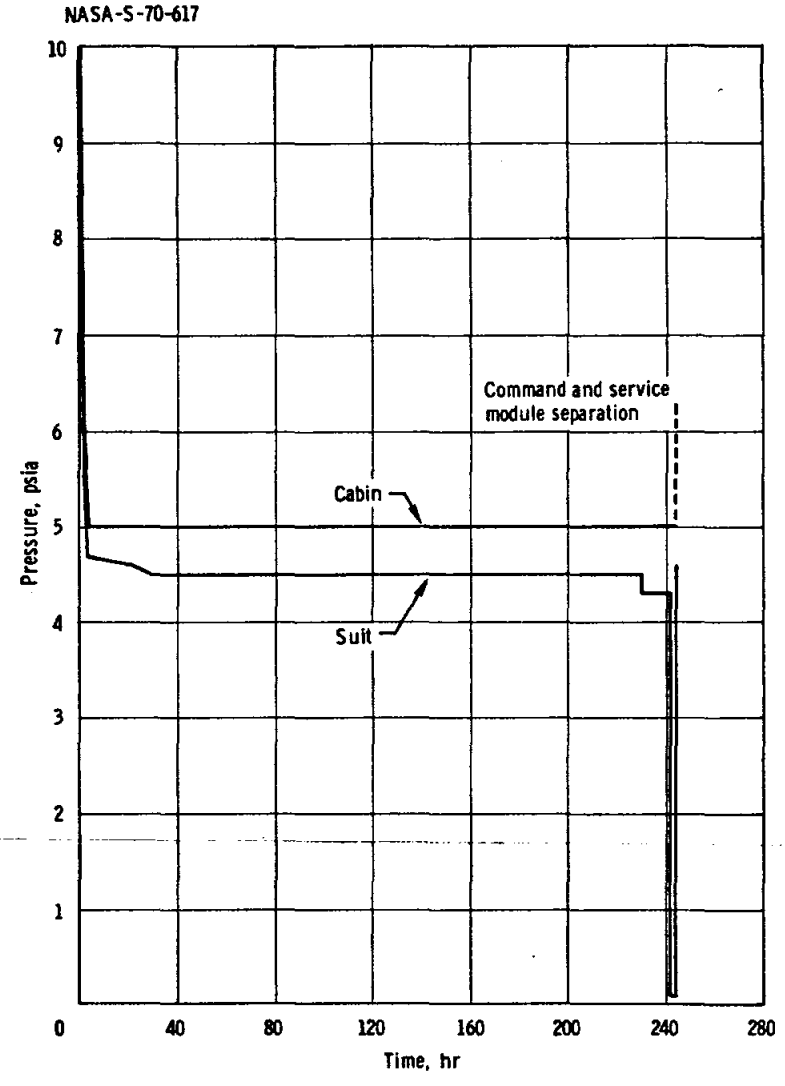
The suit pressure transducer operated properly throughout the prelaunch and launch activities. When the helmets and gloves were removed after launch, the transducer indicated 0.2-psid less than cabin pressure and at approximately 22 hours the differential was 0.4 psid. A 0.4- to 0.6-psid disparity existed between the indicated suit loop and cabin pressures until the final hours of the mission (fig. 14-22).

Figure 14-22. - Suit and cabin pressure history

At 241:41, the suit pressure transducer reading dropped to 0.1 psia, while cabin pressure was stable at 5.0 psia. About 3 hours later, at command module/service module separation, the transducer recovered to 4.6 psia. The transducer indicated a 0.4- to 0.5-psid discrepancy throughout entry. Postflight tests of the installed transducer repeated the flight anomaly. However, during subsequent tests of the removed transducer, the unit operated normally. The transducer was then returned to the manufacturer's facility, where flushing and disassembly revealed internal contamination from metallic nickel-plating particles. These particles could have caused an irregular transducer output by physically interfering with the Bourdon tube movement or by changing the inductance field of the unit. After the transducer was cleaned and reassembled, testing produced satisfactory operation. The noted contamination apparently resulted from either improper cleaning procedures or from self-generated particles within the unit.

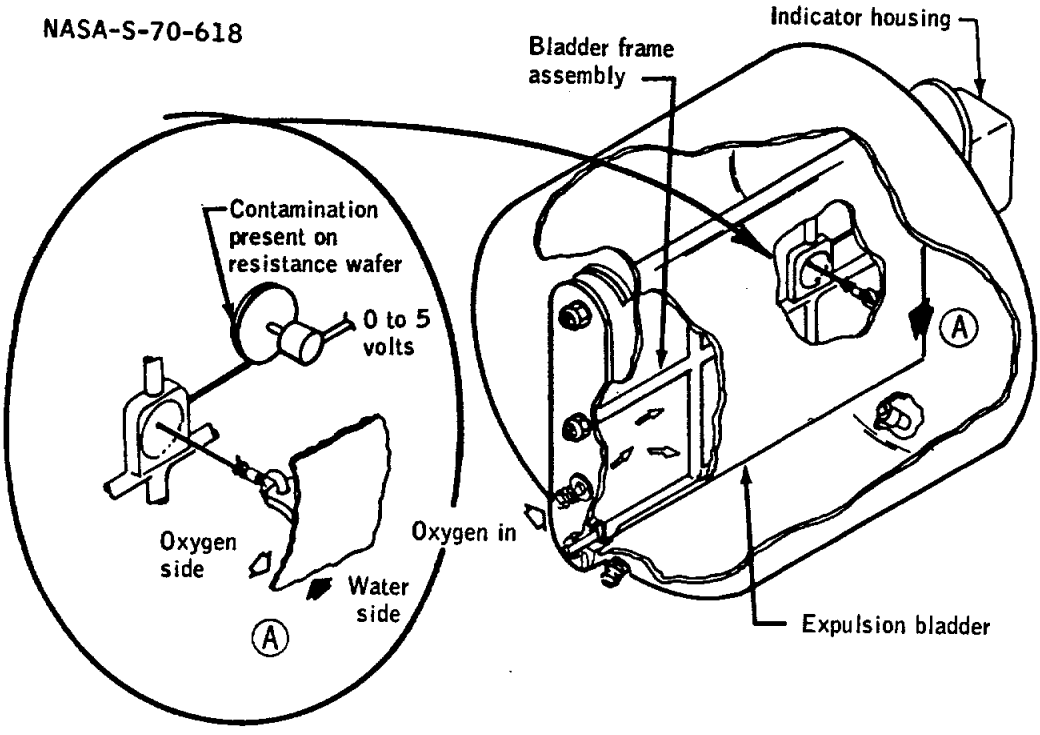
Tests of the potentiometer reproduced the output fluctuations for wiper positions equal to approximately zero quantity (zero volts) and full quantity (5 volts). The potentiometer was disassembled and appeared clean and free of contamination except for a slight stain on the end surfaces of the resistance wafer (fig. 14-24) corresponding to wiper positions for the 0 and 5 volts. The film was removed with a water-moistened swab, but the quantity of contaminate was too small to be identified.

Figure 14-23.- Area of failure in erratic potable water transducer.

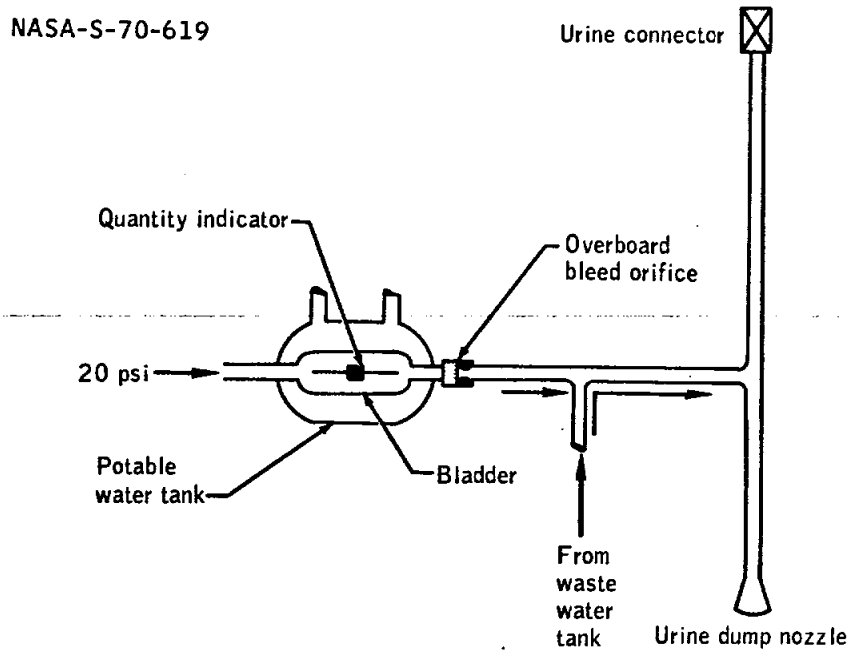
Tank calibration data after flight compared favorably with those from preinstallation calibrations. Disassembly and inspection revealed that corrosion had partially obstructed the oxygen overboard bleed orifice (fig. 14-23). No evidence was found of moisture or urine contamination on components of the water measuring system.

Figure 14-24.- Schematic of oxygen bleed flow and overboard urine dump line.

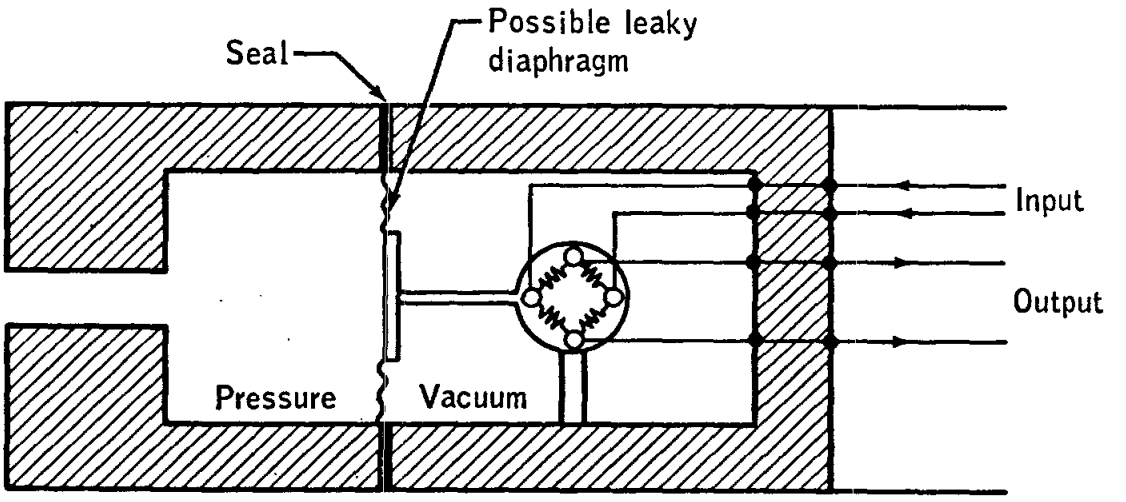
The apparent pressure drop has been attributed to a pressure transducer failure, with the most probable failure mode being a small leak through or around the stainless steel diaphragm in the transducer (fig. 14-25). Such a leak would allow hydrogen to enter the vacuum reference chamber of the transducer, thus destroying the normal pressure differential across the diaphragm. This reduction would result in the indicated pressure decay observed during the flight. A similar transducer failure occurred during a production fuel cell pre-test checkout.

Figure 14-25.- Fuel cell 3 transducer schematic.

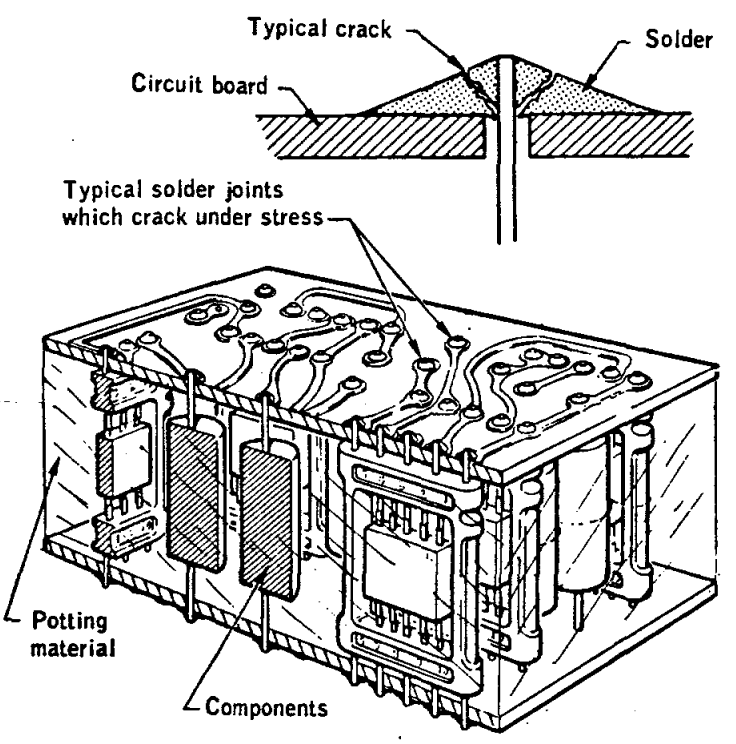
Based on previous mission clock failures, the most probable cause for this anomaly is a cracked solder joint in the cordwood construction. As seen in figure 14-26, electrical components (resistors, capacitors, diodes, etc.) are soldered between two circuit boards, and the void between the boards is filled with potting compound. The differential expansion between the potting compound and the component leads can cause solder joint cracks.

Figure 14-26.- Mission timer construction.

New mission timers, which will be mechanically and electrically interchangeable with present clocks, are being developed for Apollo 13 and subsequent spacecraft. The new clock design eliminates the cordwood construction and is less susceptible to electromagnetic interference.

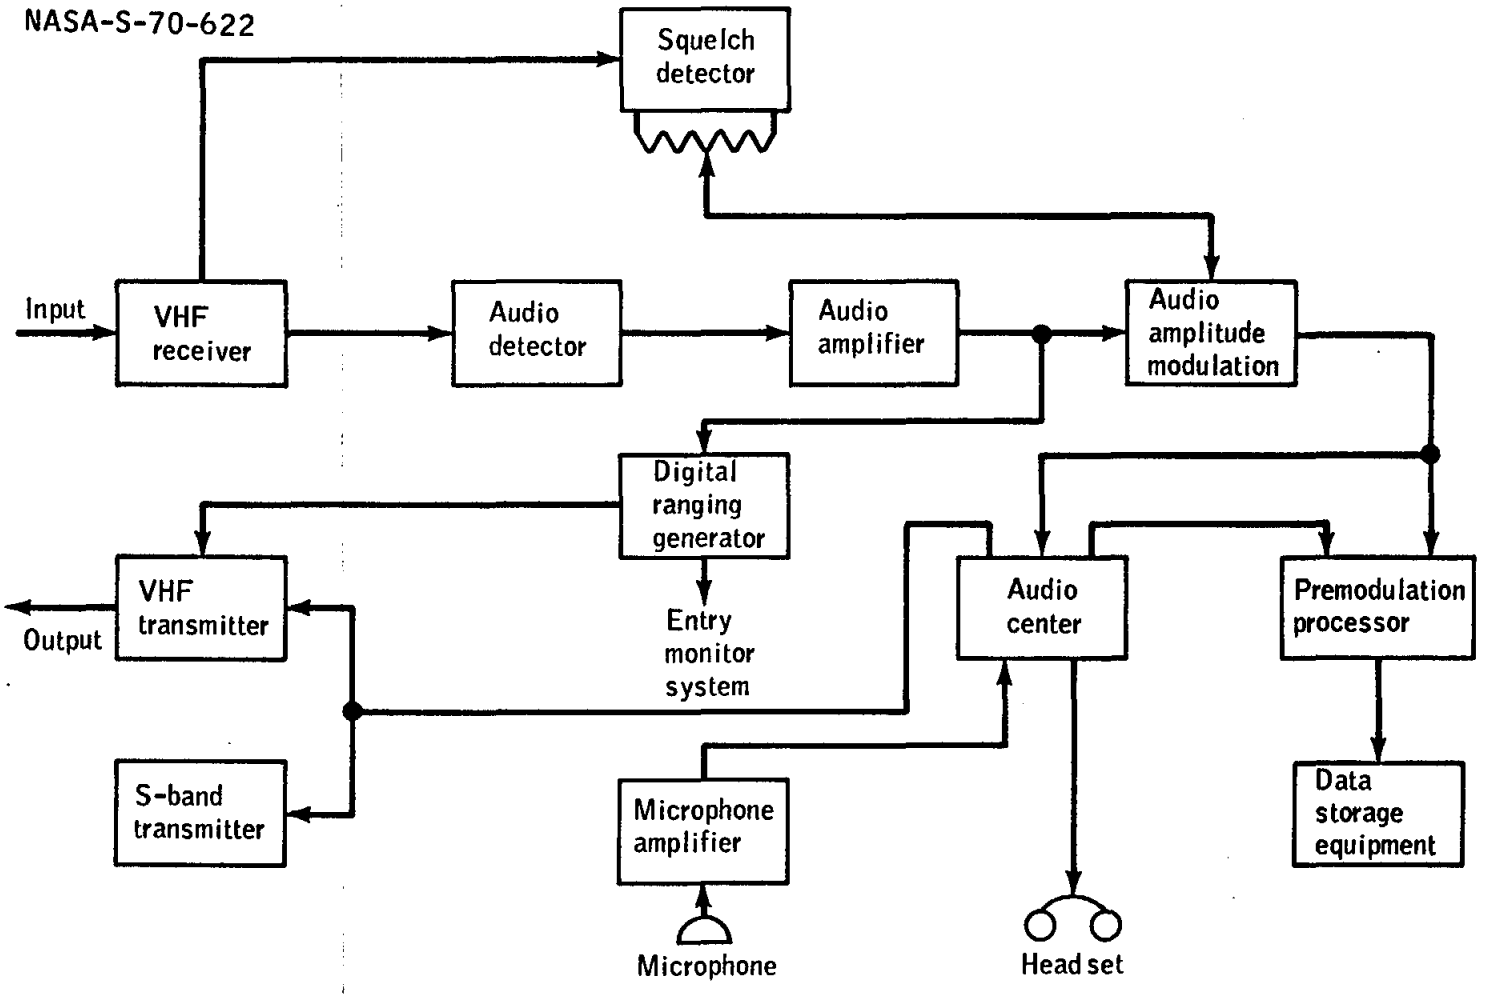
During the time period from 142:43:00 to approximately 142:53:00, the signal strength was strong enough to maintain the squelch circuit open, as verified by flight data. During the concentric sequence initiation maneuver, the squelch was noted as dropping in and out. According to predictions, the selection of either the left or the right command module antenna did not significantly affect voice communications. During this time, the received signal strength (fig. 14-28) was approximately minus 105 dBm while using the command module right antenna and lunar module forward antenna. This figure also shows the signal strength to be minus 102 dBm or less while using the command module left antenna and lunar module forward antenna according to the flight plan. From previous tests, the squelch thumbwheel, when set at approximately 6, requires from minus 100 to 105 dBm to unsquelch the audio signal.

Figure 14-27.- Command module VHF communications configuration.

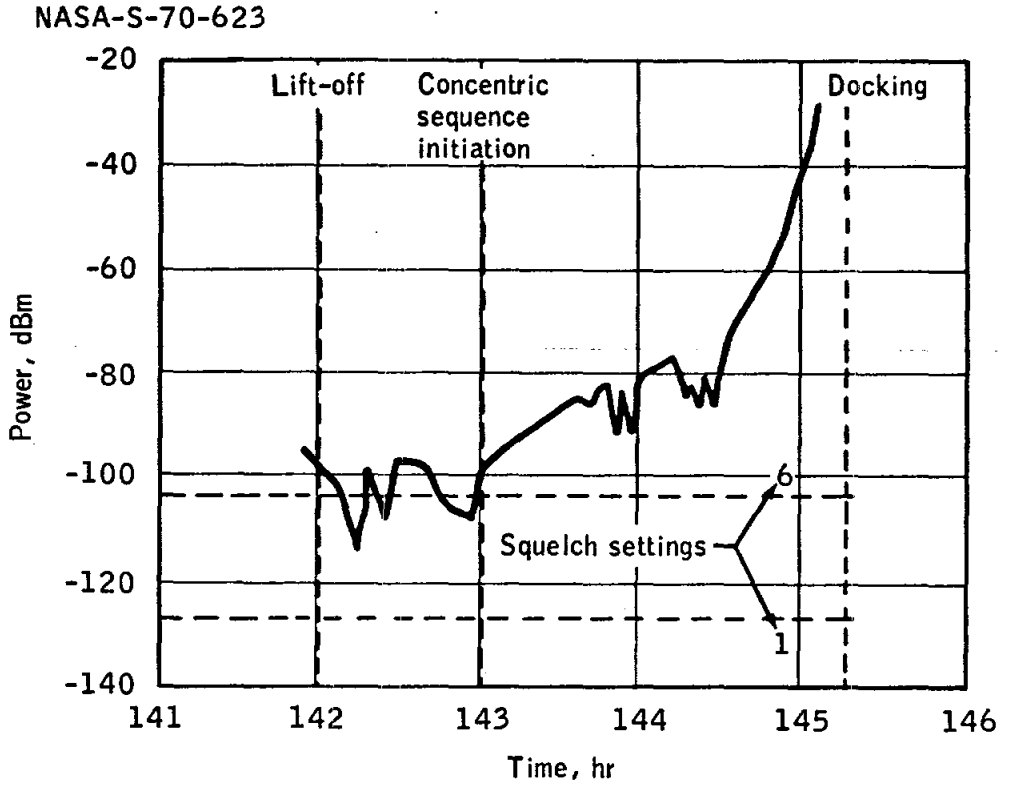
Figure 14-28.- Spacecraft received power.

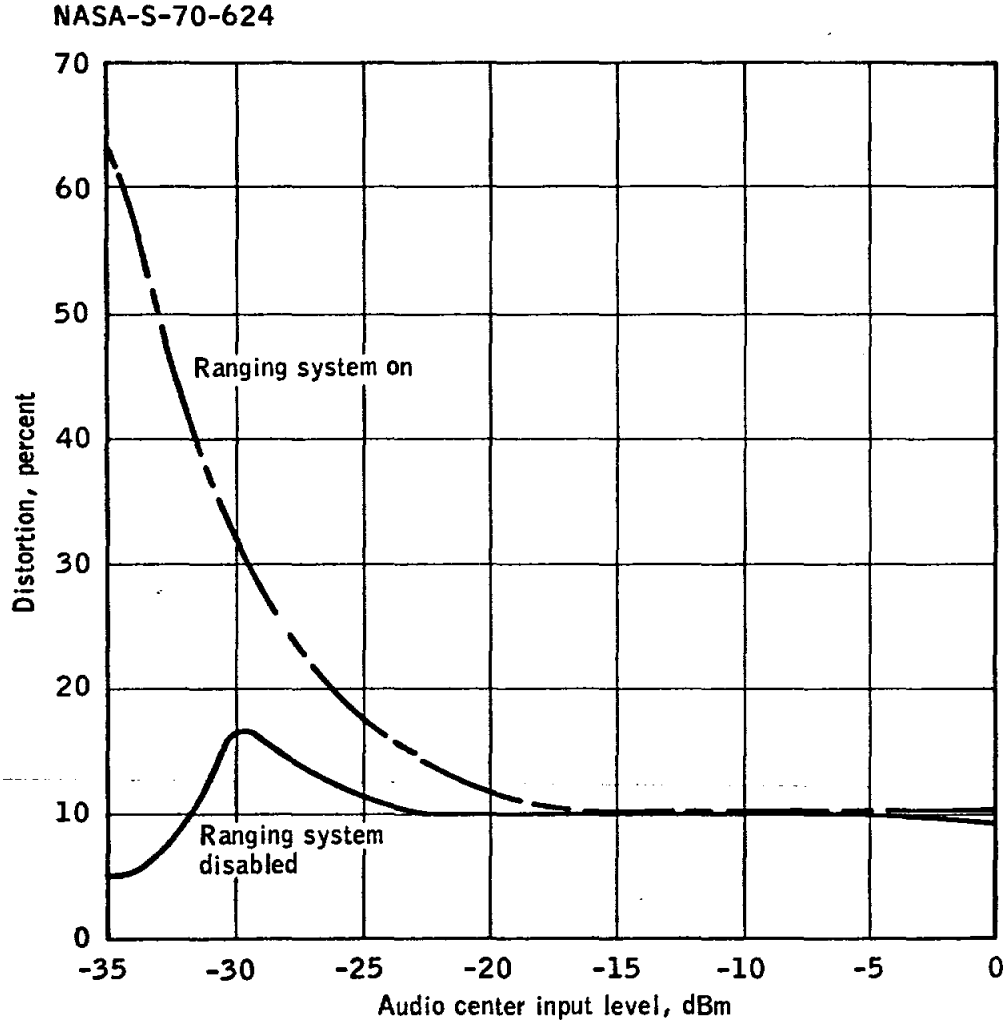
reduced level can then cause a voice-operated dropout of the voice operated transmitter. Such dropout did not occur at this time, because the Command Module Pilot was using the push-to-talk mode. Figure 14-29 shows the percent distortion of the lunar module received signal versus the command module audio center input, both with and without ranging. The curve shows that, in the ranging mode as the input level to the audio center decreases, distortion of the received signal increases significantly. This distortion cannot be directly related to intelligibility, but it does indicate that system performance is degraded by the low input levels.

Figure 14-29.- Lunar module received VHF audio distortion.

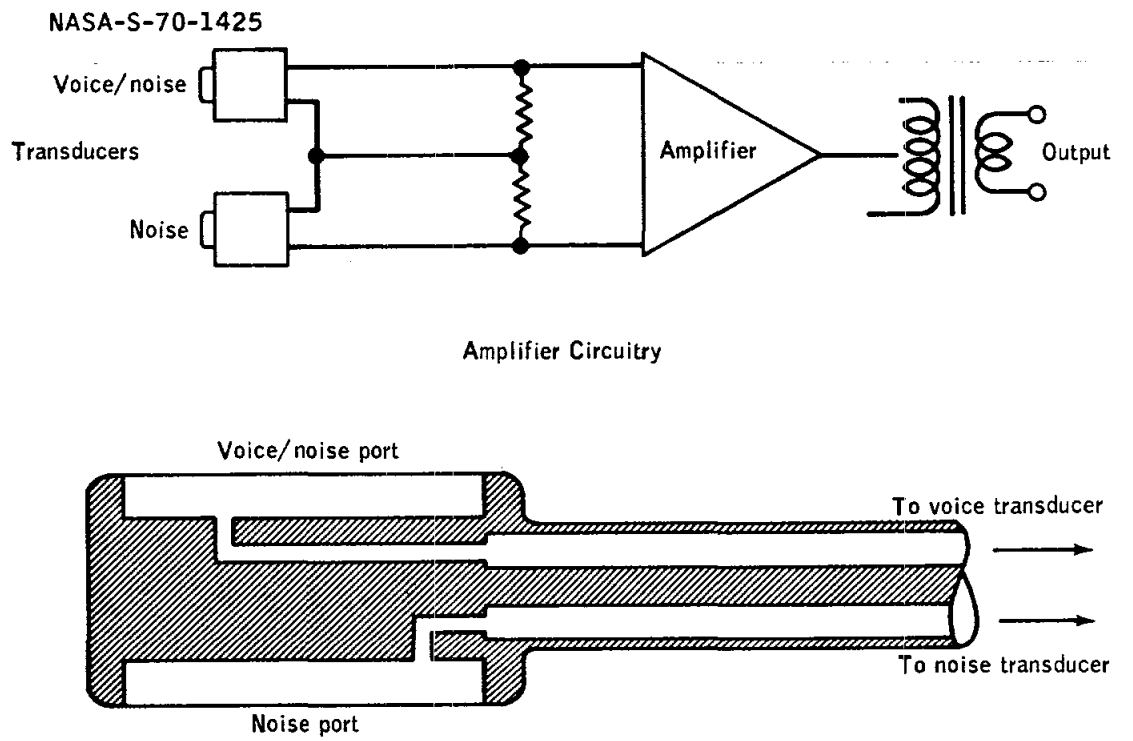
The headset microphone was designed to provide noise cancelling through mechanical spacing of the voice-capture and noise-cancelling ports (fig. 14-30). The output of the microphone amplifier is the amplified difference between the voice and noise transducer outputs. Therefore, with improper microphone placement, voice transmissions also enter the noise port, partially cancel transmissions entering the voice port, and thereby reduce the overall voice output level.

Figure 14-30.- Headset microphone voice/noise ports and amplifier circuitry.

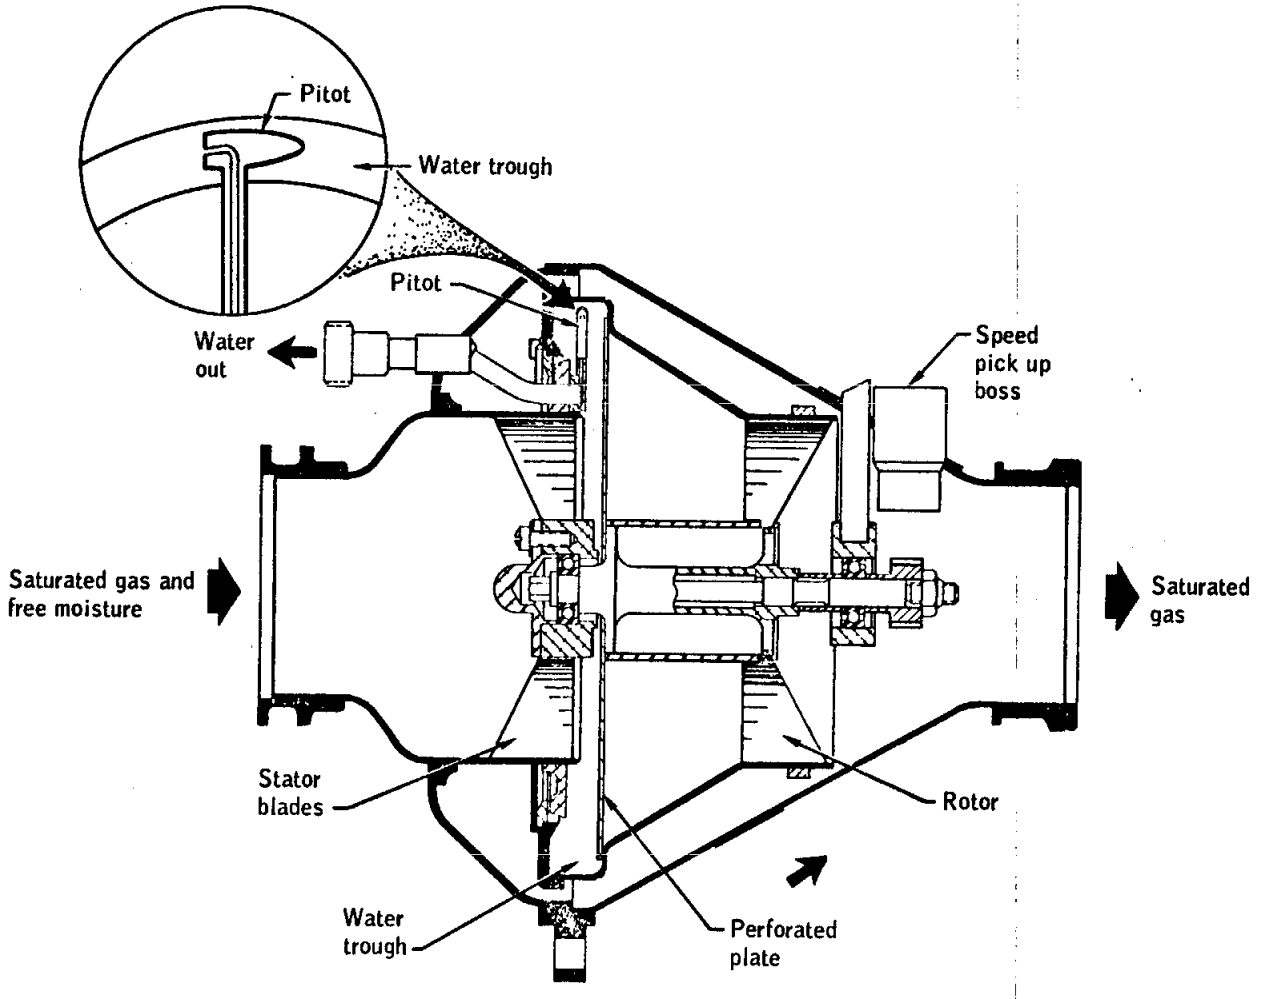
The water separator speed indication was above the upper limit (in excess of 3600 revolutions per minute) for about 50 percent of the mission. Since the water separator is a gas-driven centrifugal pump, this high speed indicates a higher than normal gas flow through the separator. Tests have shown that, at separator speeds in excess of 3700 revolutions per minute, water splashing occurs at the pitot tube (fig. 14-31) allowing water to bypass the separator.

Figure 14-31.- Water separator and pitot configuration.

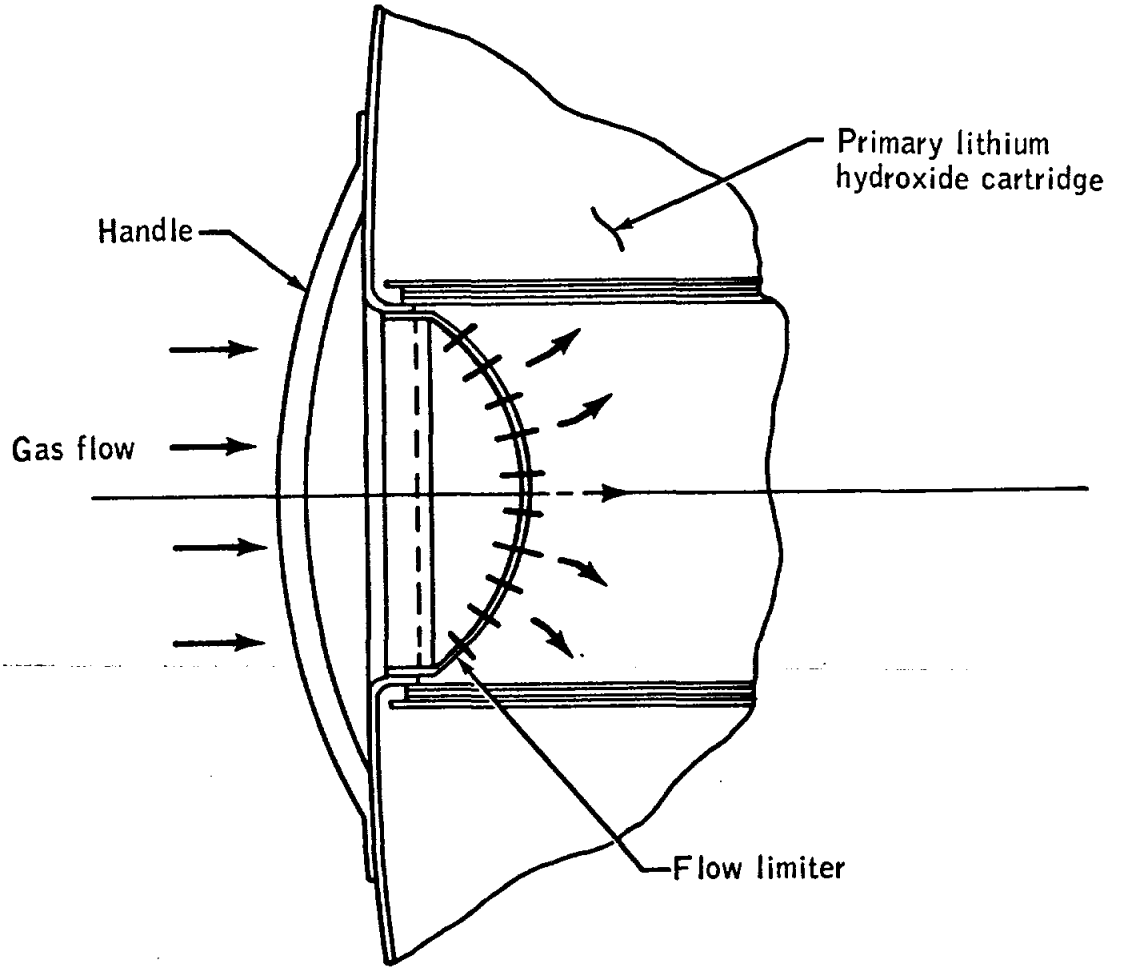
Figure 14-32.- Suit circuit flow limiter.

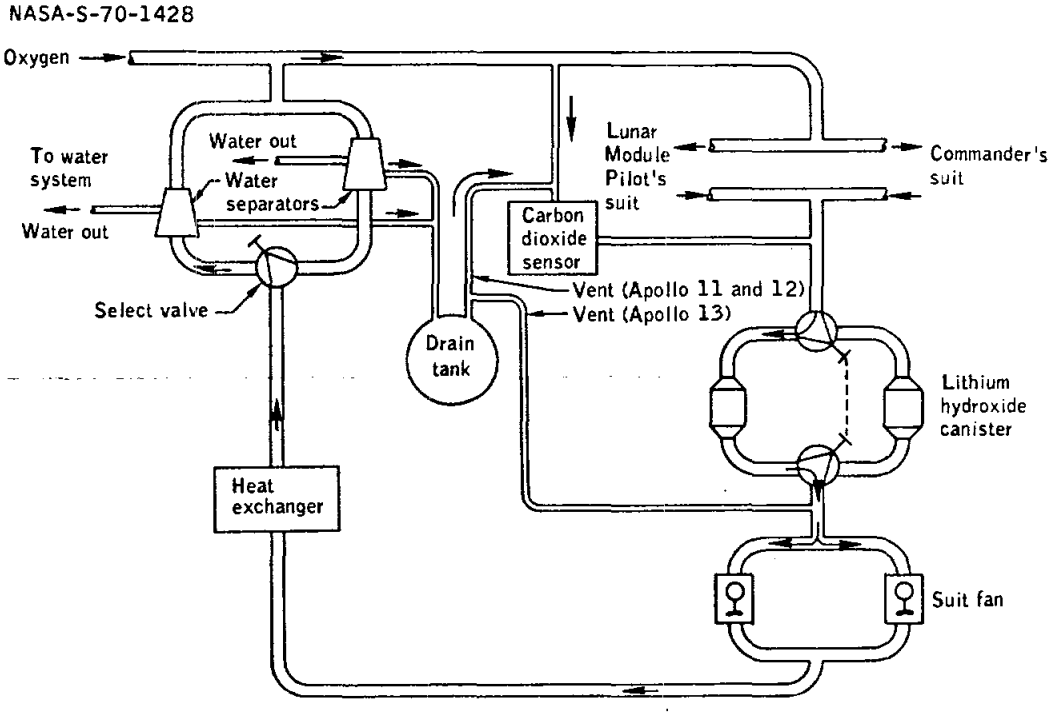
The carbon dioxide sensor is sensitive to free water, and the malfunction was probably caused either by water from the water separator sump tank entering the sensor or by water bypassing the water separator and entering the sensor. The water separator sump tank vent line joins the carbon dioxide sensor inlet sense line (fig. 14-33). This vent line has been rerouted for Apollo 13 and subsequent vehicles.

Figure 14-33.- Simplified suit loop schematic.

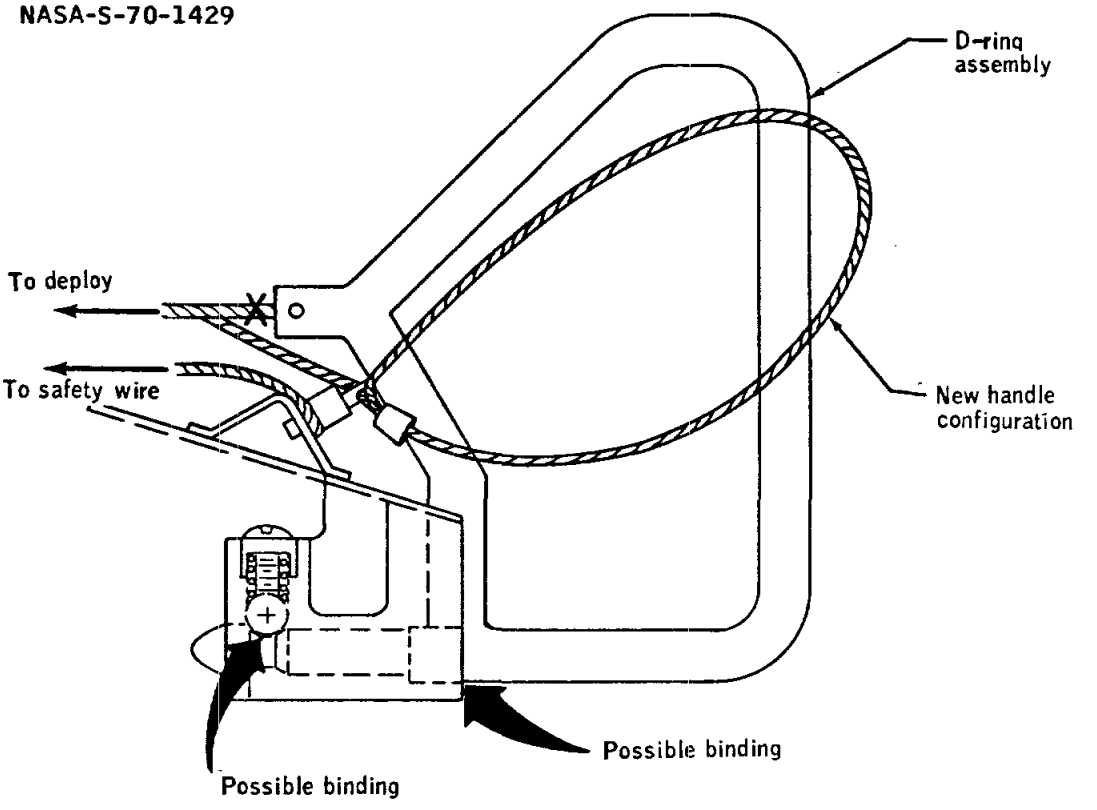
Figure 14-34.- Deployment handle (D-ring) on the modular equipment storage assembly.

For Apollo 13 and subsequent, the D-ring will be deleted and a loop will be clamped to the end of the deployment cable. The loop will be retained using the same type of pin presently installed to retain the safety wire (fig. 14-34).

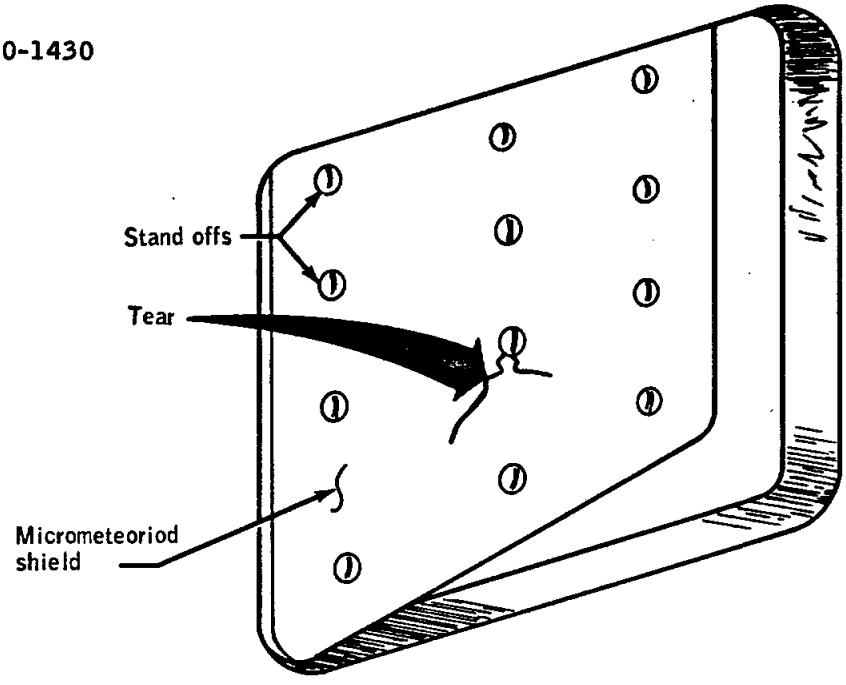
Figure 14-35.- Tear in forward hatch outer skin.

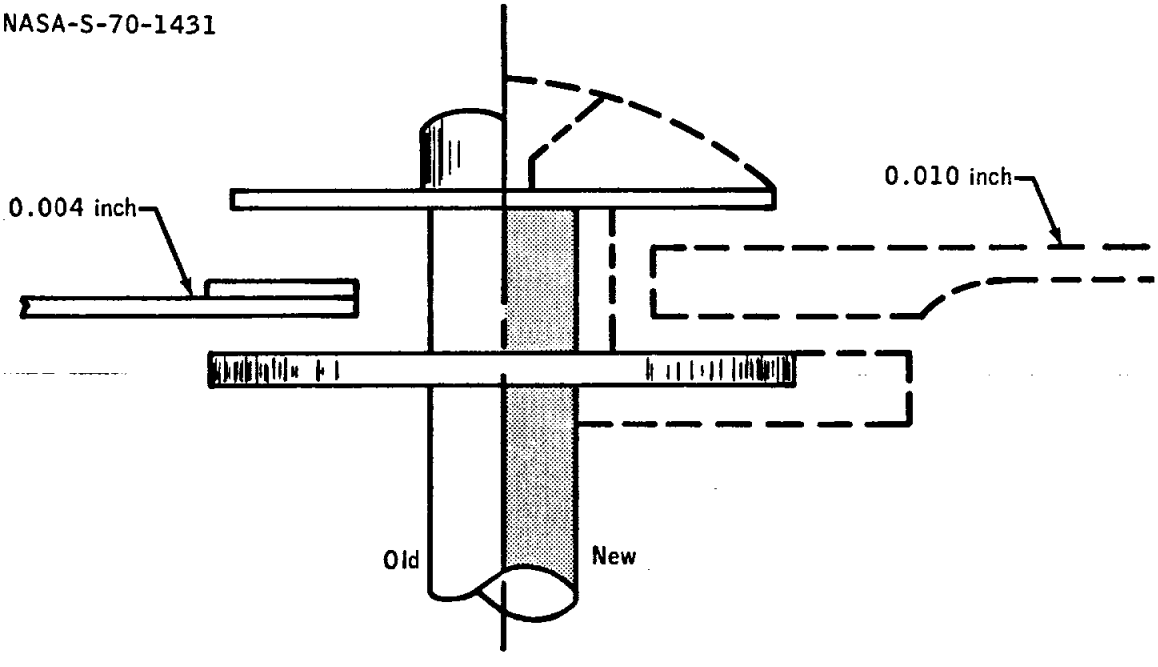
Figure 14-36.- Forward hatch standoff configuration.

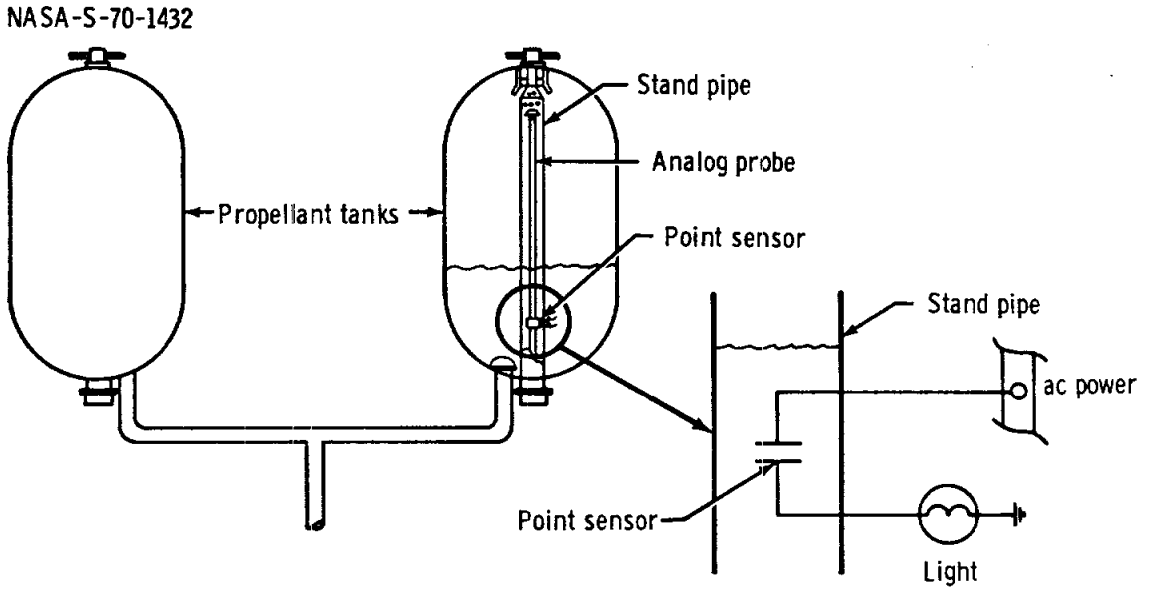
The low-level light for descent propulsion propellant quantities illuminated about 25 seconds early. The low-level light is activated and remains latched on when any one of the four low-level point sensors (one in each propellant tank) is uncovered (fig. 14-37).

Figure 14-37. - Descent propellant tank low-level sensor schematic.

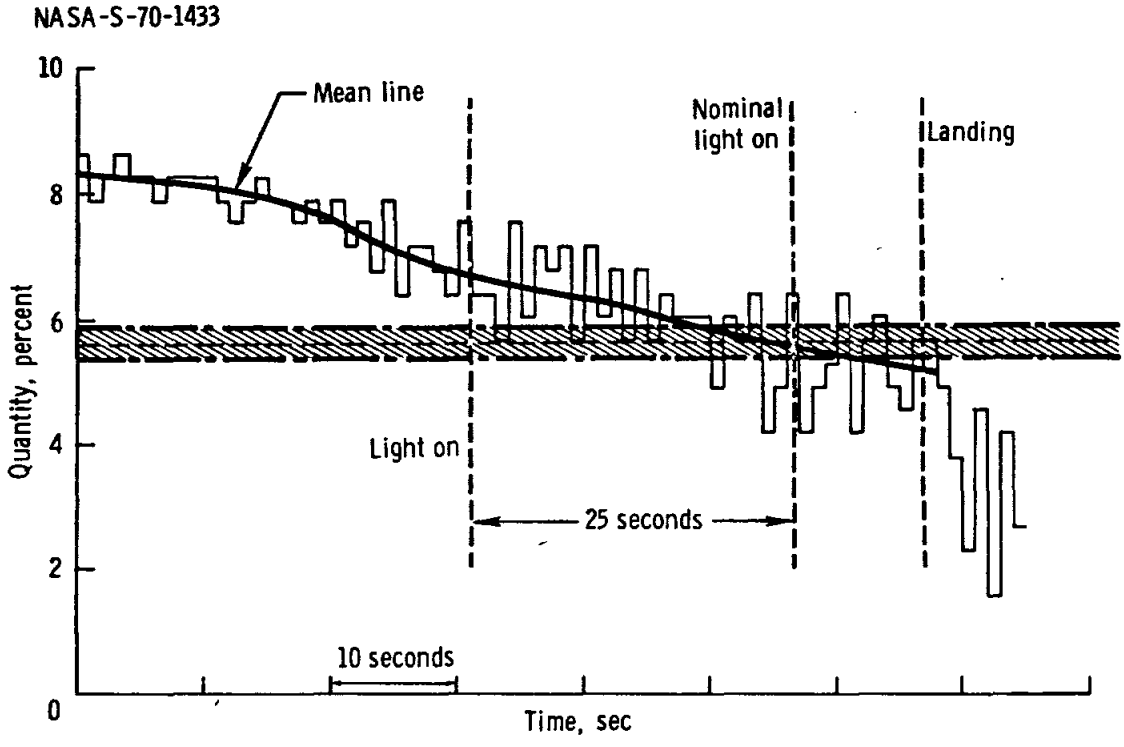
The quantity warning light should illuminate when the lowest indicated propellant level remaining in any tank reaches a value of 5.6 ±1/4 percent. Since the light came on when the averaged quantity measurement indicated 6.7 percent with an oscillation of ±1.1 percent, the

lowest excursion of the quantity reading was 5.6 percent and the display operated properly. The averaged propellant quantity reached 5.6 percent about 25 seconds later.

Figure 14-38.- Descent propellant quantity just prior to landing.

For Apollo 13, the quantity measurements for the four descent propellant tanks have been increased in sampling rate from 1 to 100 samples per seconds. These data will be averaged automatically and used to determine the low-level point from which the remaining firing time can be calculated. The 100 samples per second rate will provide data that will permit an understanding of the particular dynamics of the fluid in the tanks.

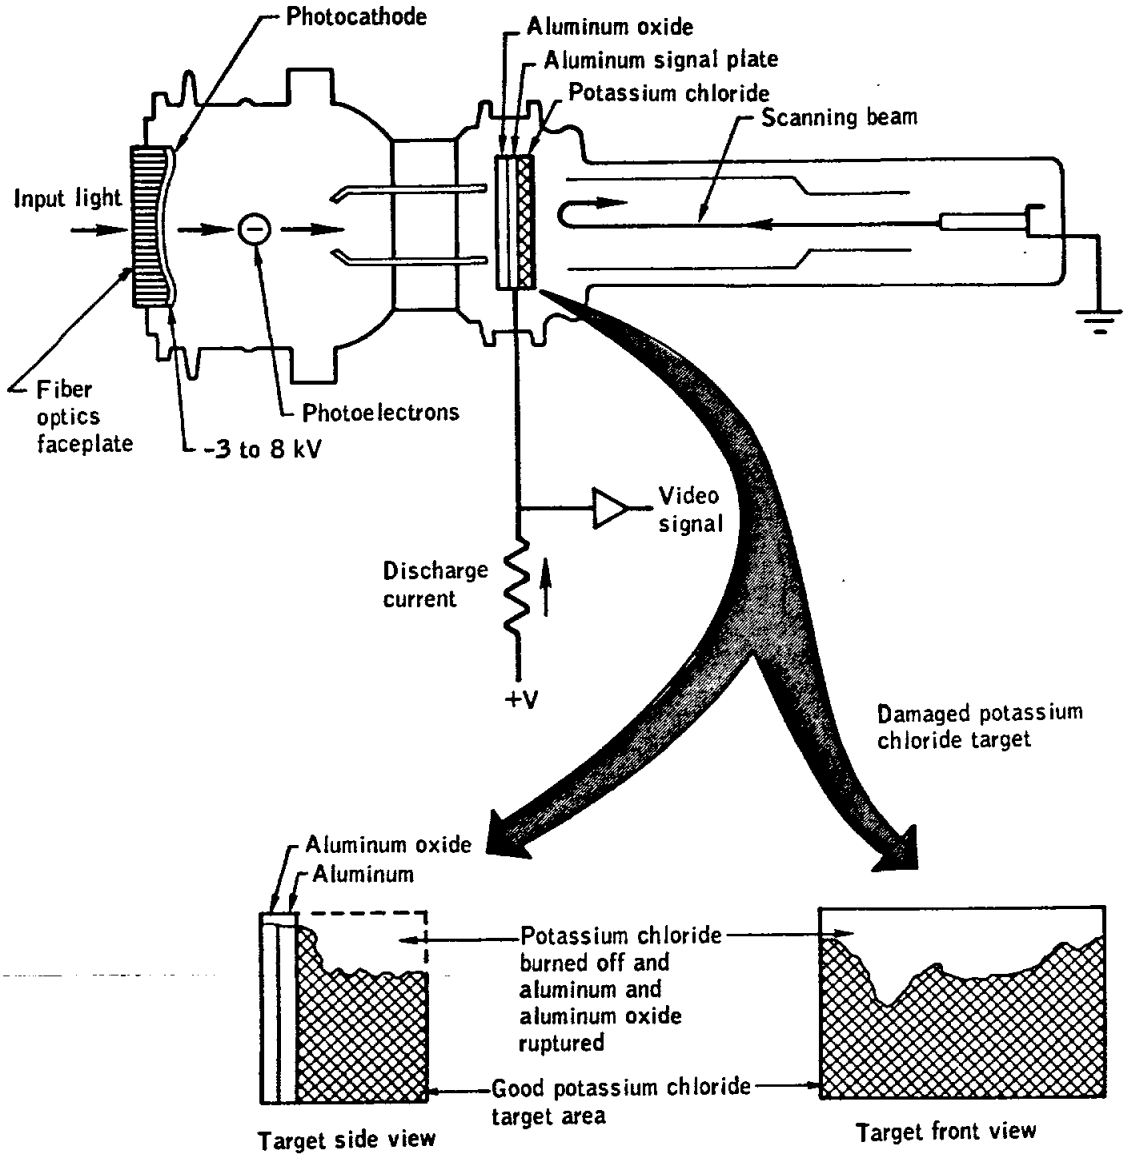
After decontamination and cleaning, the flight camera was inspected and power was applied. The image, as viewed on a monitor, was the same as that last seen from the lunar surface. The automatic light-level control circuit was disabled by cutting one wire. The camera then reproduced good scene detail in that area of the picture which had previously been black, verifying that the black area of the target was undamaged, as shown in figure 14-39. This finding also proved that the combination of normal automatic light control action and a damaged image-tube target caused the loss of picture. In the process of moving the camera on the lunar surface, a portion of the target in the secondary-electron conductivity vidicon must have received a high solar input, either directly from the sun or from some highly reflective surface. That portion of the target was destroyed, as was evidenced by the white appearance of the upper part of the picture.

Figure 14-39.- Secondary electron conductivity tube in the color television.

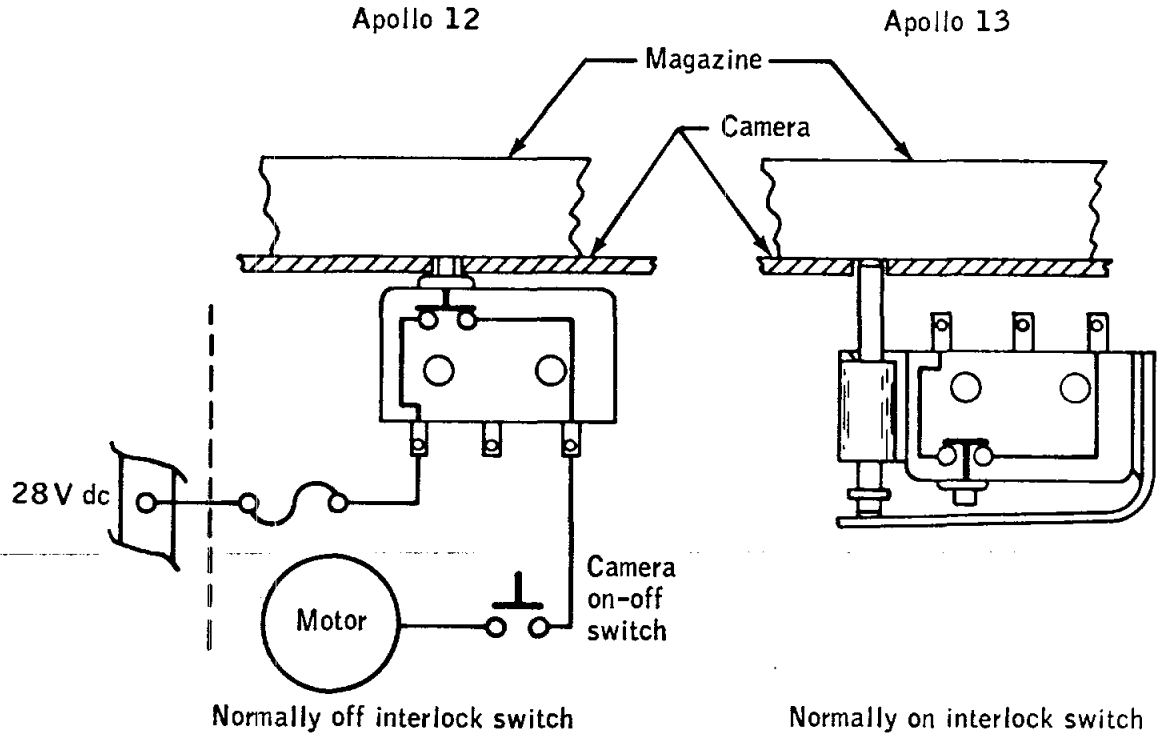
Although postflight tests showed the 16-mm camera and magazine to be in satisfactory operating condition, the characteristic sensitivity of the magazine interlock microswitch installation is such that the operating limits of the switch could cause intermittent actuation. The intermittent operation was duplicated on the flight and similar equipment by the application of pressure to the end of the magazine. The problem will be resolved by changing the interlock switch (fig. 14-40) to a configuration that is much less sensitive to variation in switch settings.

Figure 14-40.- Sequence camera interlock switch modification.
