NATIONAL AERONAUTICS AND SPACE ADMINISTRATION

# APOLLO 12 MISSION REPORT

MANNED SPACECRAFT CENTER

MARCH 1970

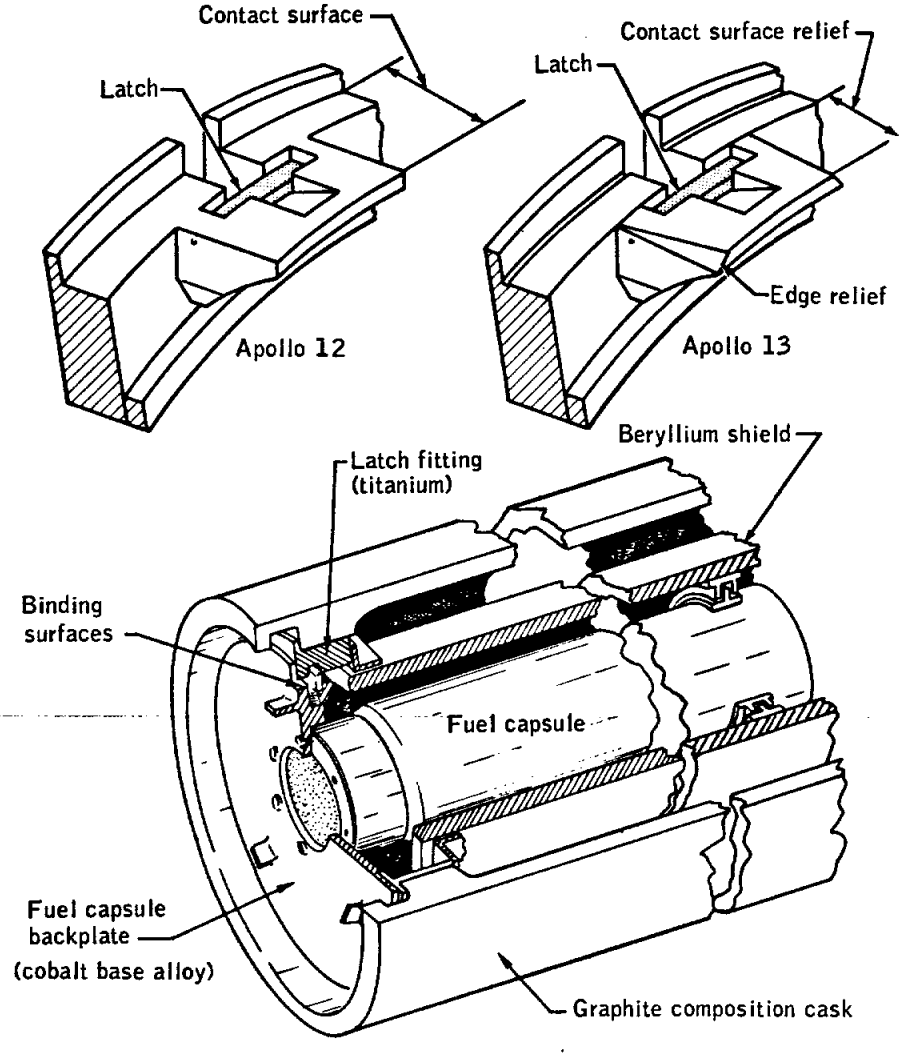
Thermal tests and analyses show that dimensional tolerances can diminish with temperature and result in binding between the latch fitting (C-ring) on the cask and the contact surface of the backplate on the fuel capsule (fig. 14-41). The longitudinal contact distance for these two surfaces is approximately 0.6 inch, and extraction was easily accomplished once this distance was negotiated.

Figure 14-41.- Radioisotope fuel capsule configuration.

As a result of the dimensional checks, the thermal tests, and analyses performed with both the qualification and Apollo 13 flight hardware, the contact surfaces of the fuel capsule backplates are being reworked as indicated in the figure. The outside diameter of the 0.10-inch long contact surface, while remaining within design limits, may be reduced as much as 0.005 inch for ease of capsule extraction. All existing capsule backplates will be reworked in this manner.

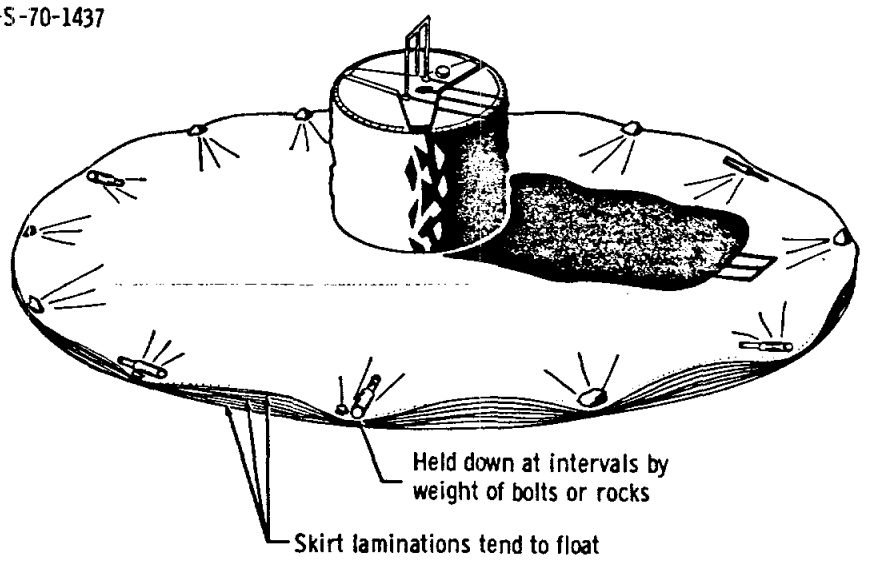
The thermal shroud tended to delaminate and rise up off the lunar surface. This condition had been anticipated, and lunar soil was placed on the periphery of the shroud to hold it down. When this operation proved difficult, tie-down bolts, which had been removed from the pallet during deployment of the experiments package, were placed on the shroud with satisfactory results (fig. 14-42).

Figure 14-42. - Passive seismic experiment deployed.

For Apollo 13 and subsequent spacecraft, the shroud laminations will be spot-sewed together at intervals around the periphery, a weight will be sewed to each of the six attach-pullout points on the shroud, and a 5-foot diameter Teflon blanket will be added for thermal control to decrease solar degradation.

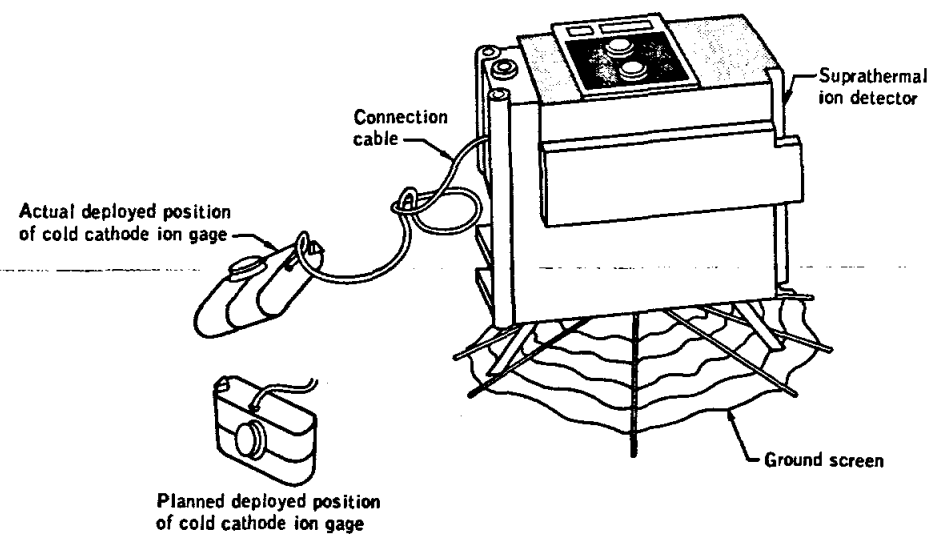
NASA-S-70-1438

The cold cathode ion gage would not remain upright when deployed. Its final position was on its back with the sensor aperture at an angle of approximately 60 degrees from the horizontal but was satisfactory (fig. 14-43).

The cable connecting the cold cathode ion gage with the suprathermal ion detector was quite stiff. The combination of the spring effect in the cable, the reduced weight of the cold cathode ion gage under lunar gravity, and the softness of the lunar surface was apparently sufficient to cause the equipment instability during deployment. Final positioning of the equipment requires that the sensor aperture does not point directly at the surface nor directly at other experiment package components. The final positioning fulfilled this requirement.

Figure 14-43.- Cold cathode gage deployed.

The combination of the suprathermal ion detector with the cold cathode ion gage will not be included for Apollo 13. For Apollo 14 this equipment will be flown, and the wires of the connecting cable will be tied at 6-inch intervals instead of being wrapped with heavy Mylar tape. This modification not only reduces cable stiffness by 70 percent, which decreases the spring effect, but also decreases cable bulkiness to permit easier stowage.

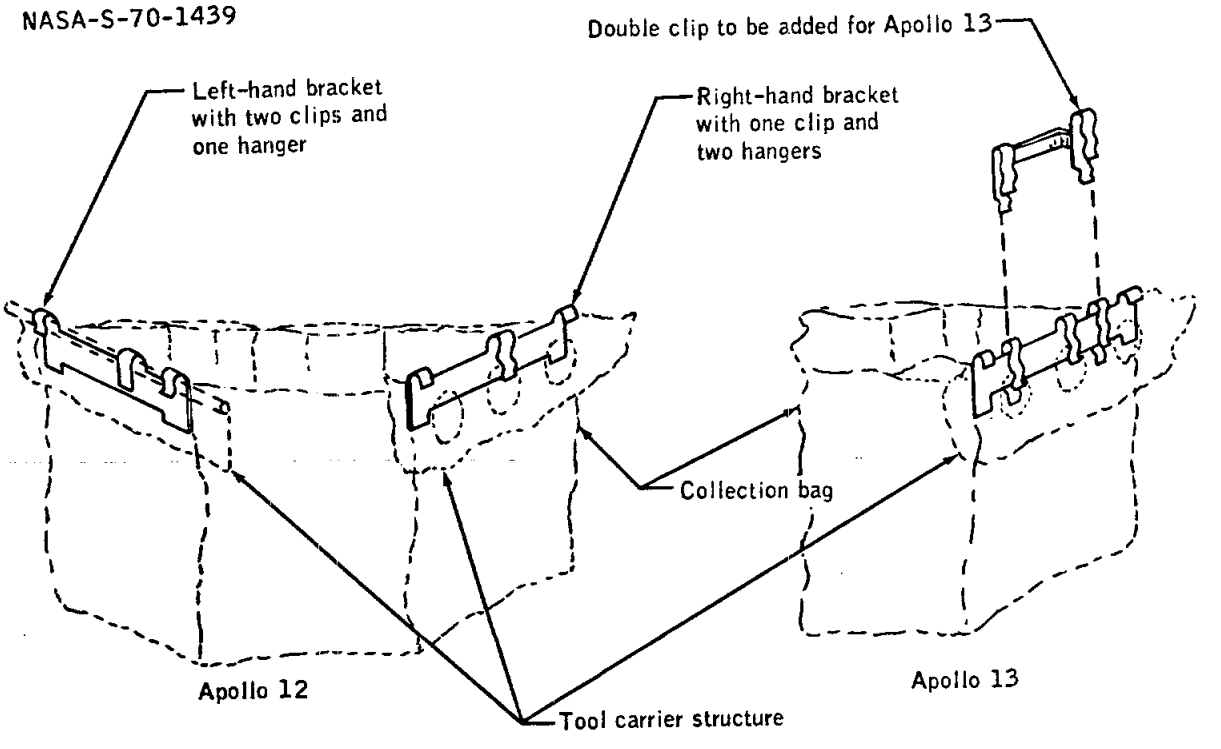
At the beginning of extravehicular activity, the empty tool carrier collection bag tended to rise out of the tool carrier until some lunar surface soil was put in to hold it down. The bag is attached to the carrier structure by three aluminum spring clips (fig. 14-44). The weight of the loaded bag is shared by these clips and three hangers. The retention force is limited so that the loaded bag may be easily lifted out of the carrier.

Figure 14-44.- Tool carrier collection bag retention.

The retention characteristics of the left side, with two spring clips over the 0.37-inch diameter rolled bead of the carrier structure, is satisfactory. However, the single spring clip over the 0.18-inch lip of the carrier on the right side did not provide sufficient positive retention. A separate double spring clip, which reaches over both the bag hanger and tool carrier structure, will be added for Apollo 13 to provide the necessary retention force as shown in the figure.

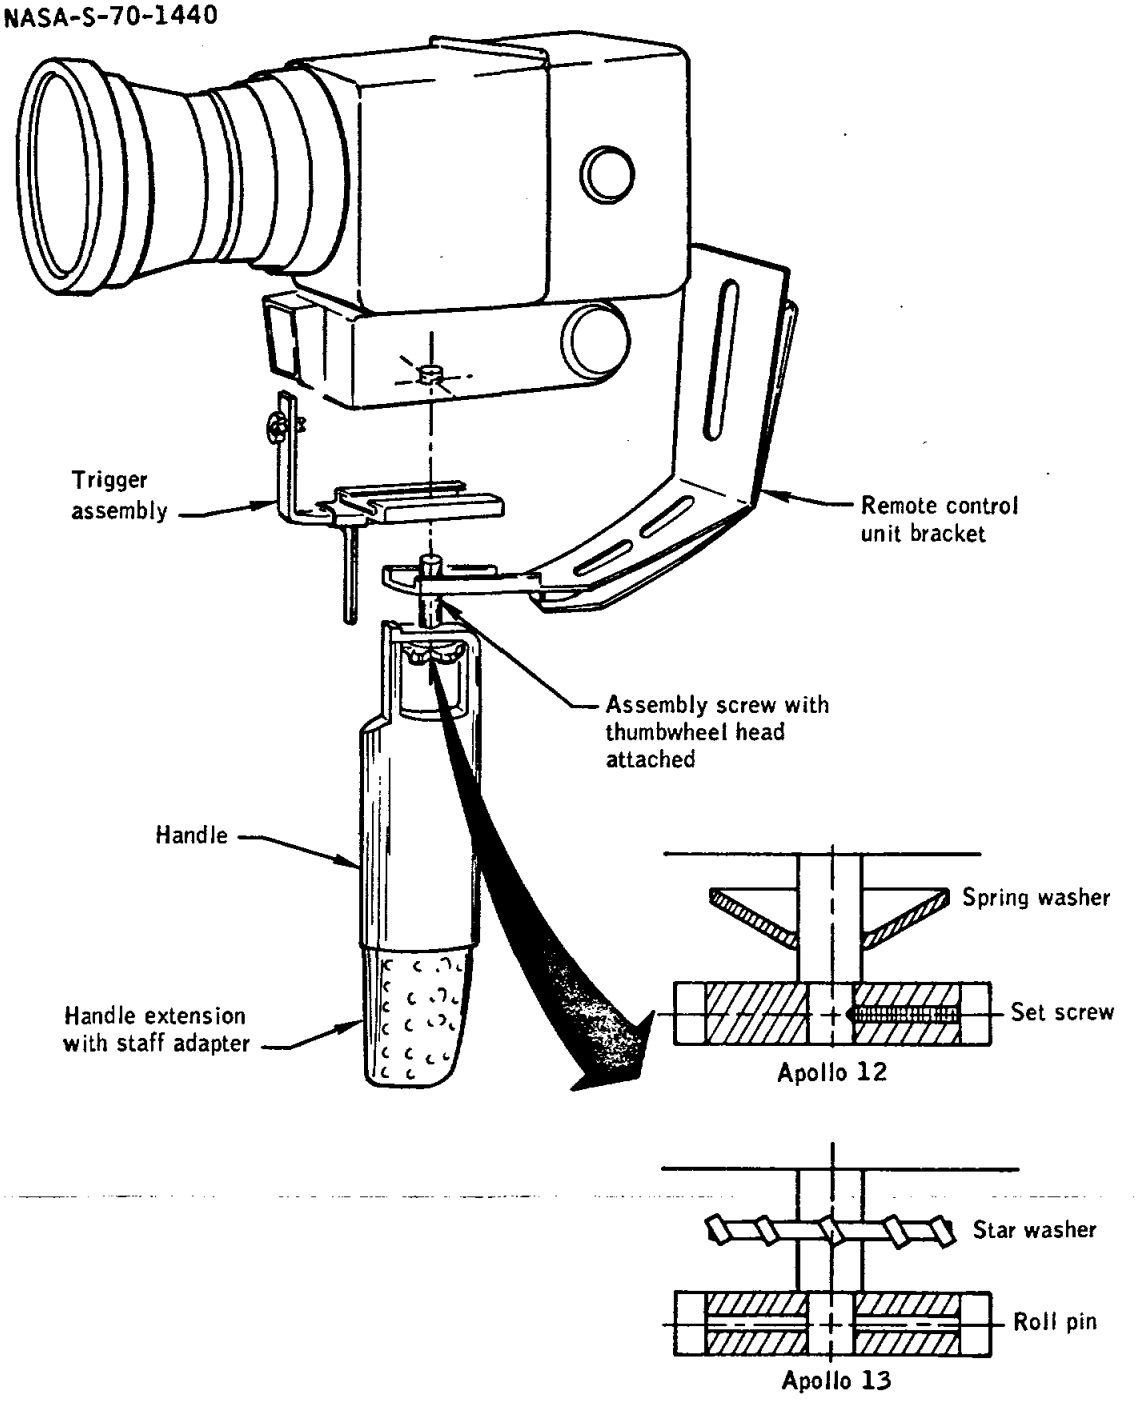
During the second extravehicular period, the Commander's camera did not advance and count every time the trigger was squeezed. Shortly afterwards, when both the camera assemblies were being removed from the remote control units in order to exchange them, both assemblies were loose, although they had been well tightened before egress. In the process of retightening on the lunar surface, the thumbwheel fell off the Lunar Module Pilot's camera assembly, making reassembly impossible (fig. 14-45). The empty camera and faulty assembly were then discarded. The Commander's camera assembly was retightened and performed satisfactorily during the remainder of the extravehicular activity.

Figure 14-45.- 70-mm camera handle assembly.

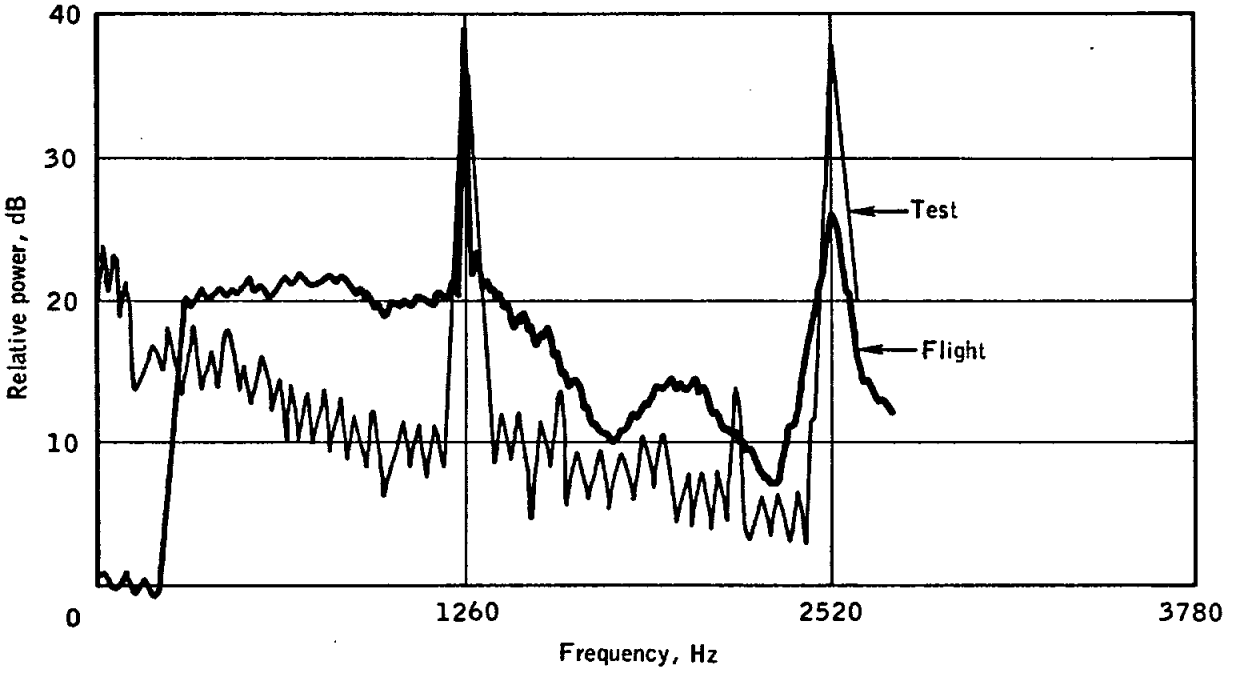
NASA-S-70-1441

A subsequent analysis of the telemetry data transmitted from the extravehicular mobility unit did not show any degradation of data quality as a result of the noise. Power spectral density plots, however, revealed a fundamental frequency of approximately 1260 hertz and a harmonic frequency of 2520 hertz. Postflight interference tests of an equivalent extravehicular mobility unit revealed the same 1260-hertz tone on the battery-bus leads and shield which originated from the fan-motor ripple current. This condition is normal and has been noted during qualification testing of the extravehicular mobility unit. Figure 14-46 illustrates the tone interference generated by the fan motor. However, during these initial tests, the noise interference could not be made to enter the audio system such that the audio tone heard in flight was simulated.

Figure 14-46.- Tone power spectral density.

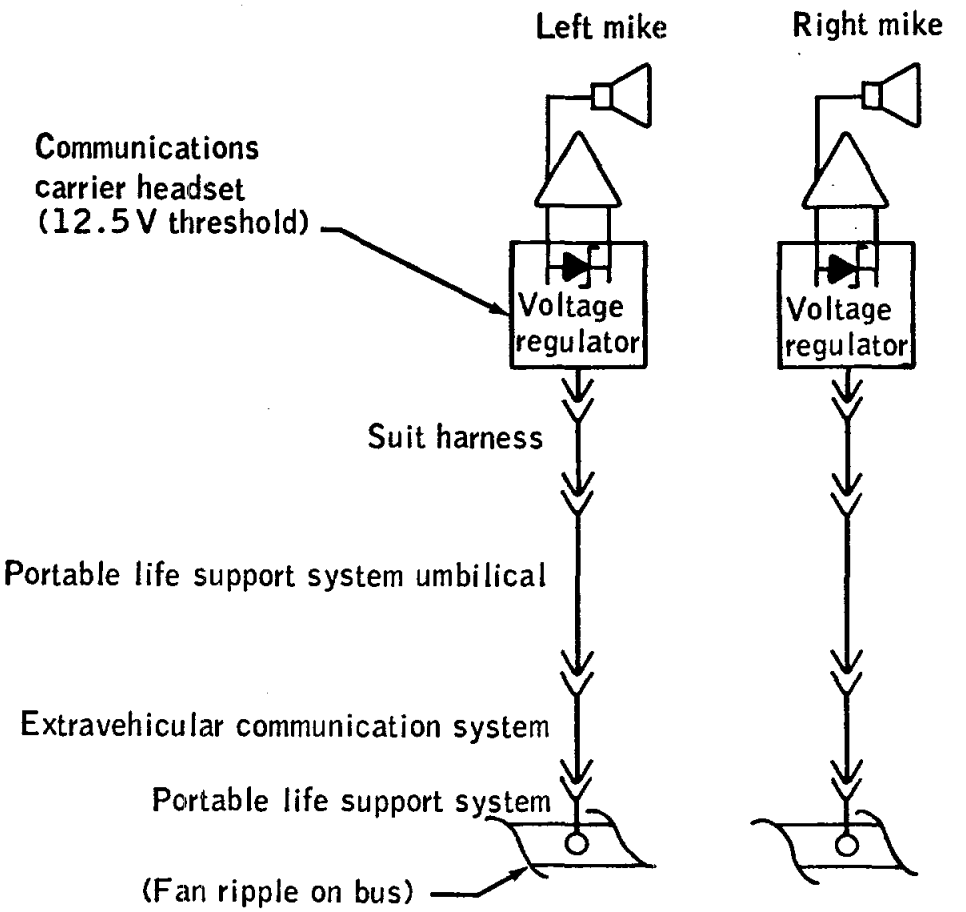
NASA-S-70-1442

Later laboratory testing of the communications carrier headset demonstrated that lowering a microphone amplifier supply voltage below the regulator threshold of 12.5 volts caused tone interference to enter the audio system. Subsequent analysis showed that a high resistance or the failure of a regulating diode or a transistor in the microphone amplifier regulator could result in a loss of regulator filtering action. The normal operating voltage for the microphone amplifier is from 15.7 to 20.5 volts. When the microphone amplifier supply voltage is above the regulator threshold of 12.5 volts, the tone interference does not enter the audio system.

Figure 14-47.- Communications carrier headset power path.
