Ground Inspection

Structural Engineering Division

Thermography Inspections

OV-103 6L Pre Impact

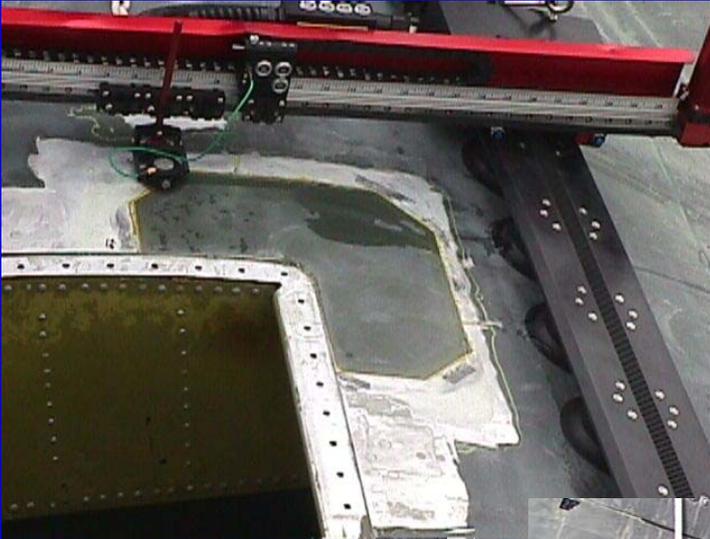
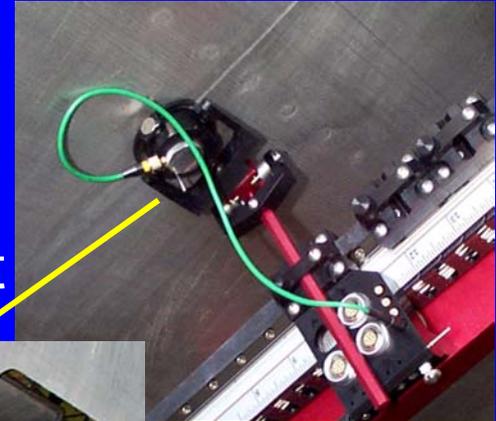
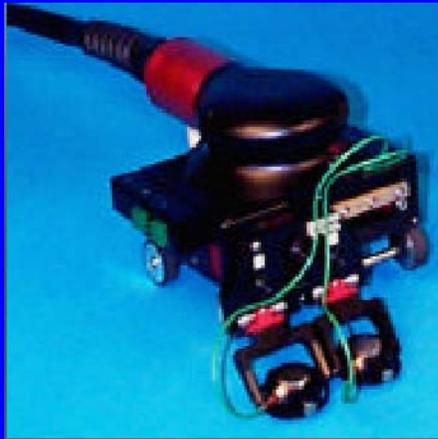
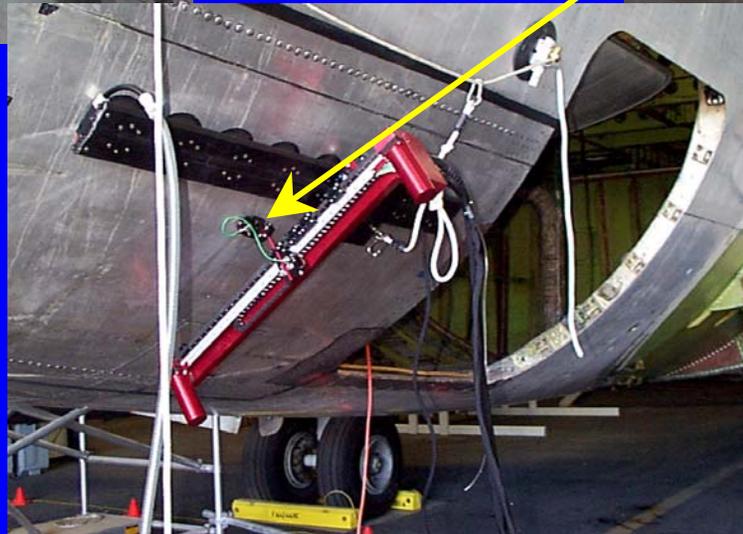
MAUS System

- Resonance
- MIA
- Pulse-echo
- Pitch-catch
- Eddy current

Interchangeable tracks allow for continuous scanning

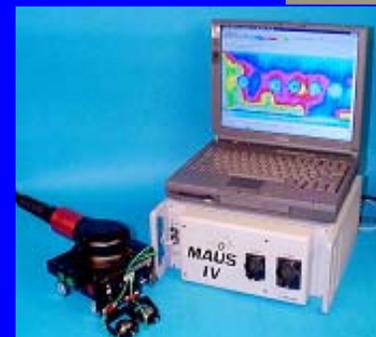
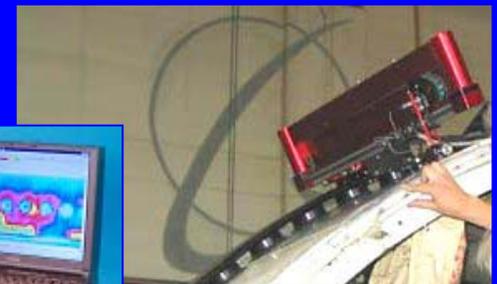
Eddy Current Inspection of RCC

- Resolution will likely be driven by presence of shallow flaws in areas of relatively large SiC thickness variations
- Sensitivity should allow us to detect 0.1" diameter and 0.005" depth material loss flaws due to oxidation in carbon-carbon at SiC carbon-carbon interface along outer surface of RCC laminate
- Integration of Eddy Current probes with MAUS scanning system has been demonstrated to produce scan rates of 36 sqft/hour.
- System will be designed to simultaneously measure SiC coating thickness and detect areas of mass loss due to carbon oxidation.
