Shuttle RMS Inspection Capability (Bottom View)

Shuttle RMS Inspection Capability (Top View)

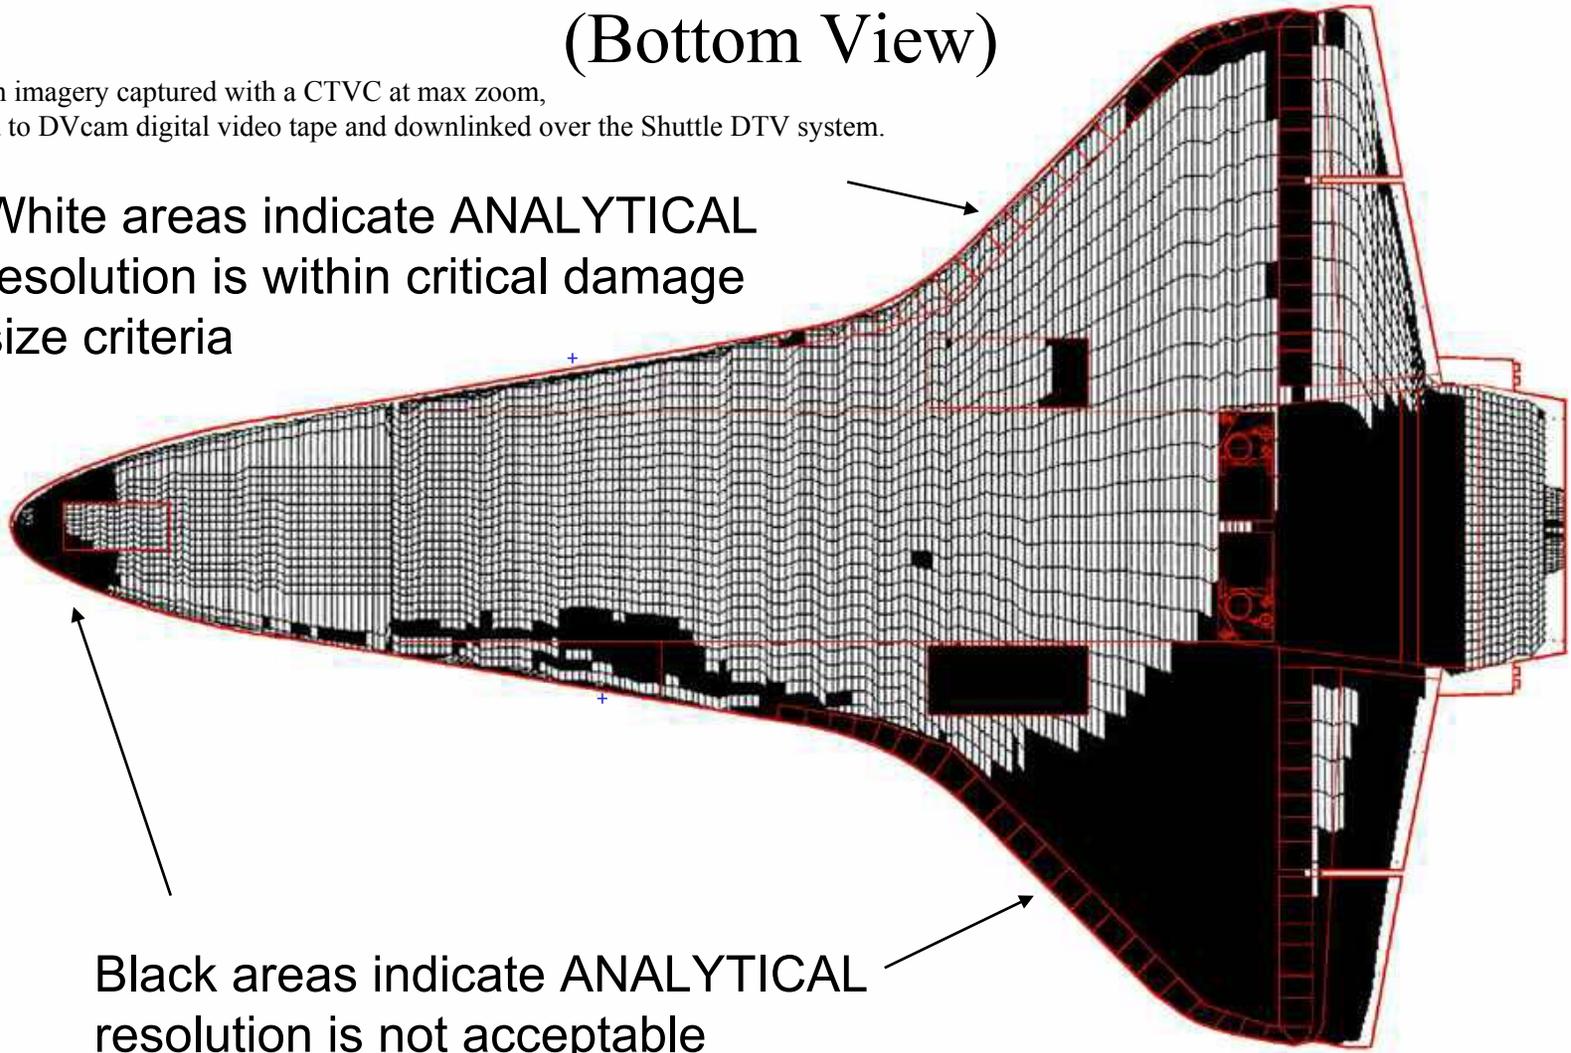
Based on imagery captured with a CTVC at max zoom,
recorded to DVcam digital video tape and downlinked over the Shuttle DTV system.

White areas indicate ANALYTICAL
resolution is within critical damage
size criteria

Black areas indicate ANALYTICAL
resolution is not acceptable

Note: Black mesh gridlines in white areas are artifacts of mapping program
and are within critical damage size criteria.

Area where black mesh gridlines merge on curved surface appear black. Area
resolvable within critical damage size criteria.

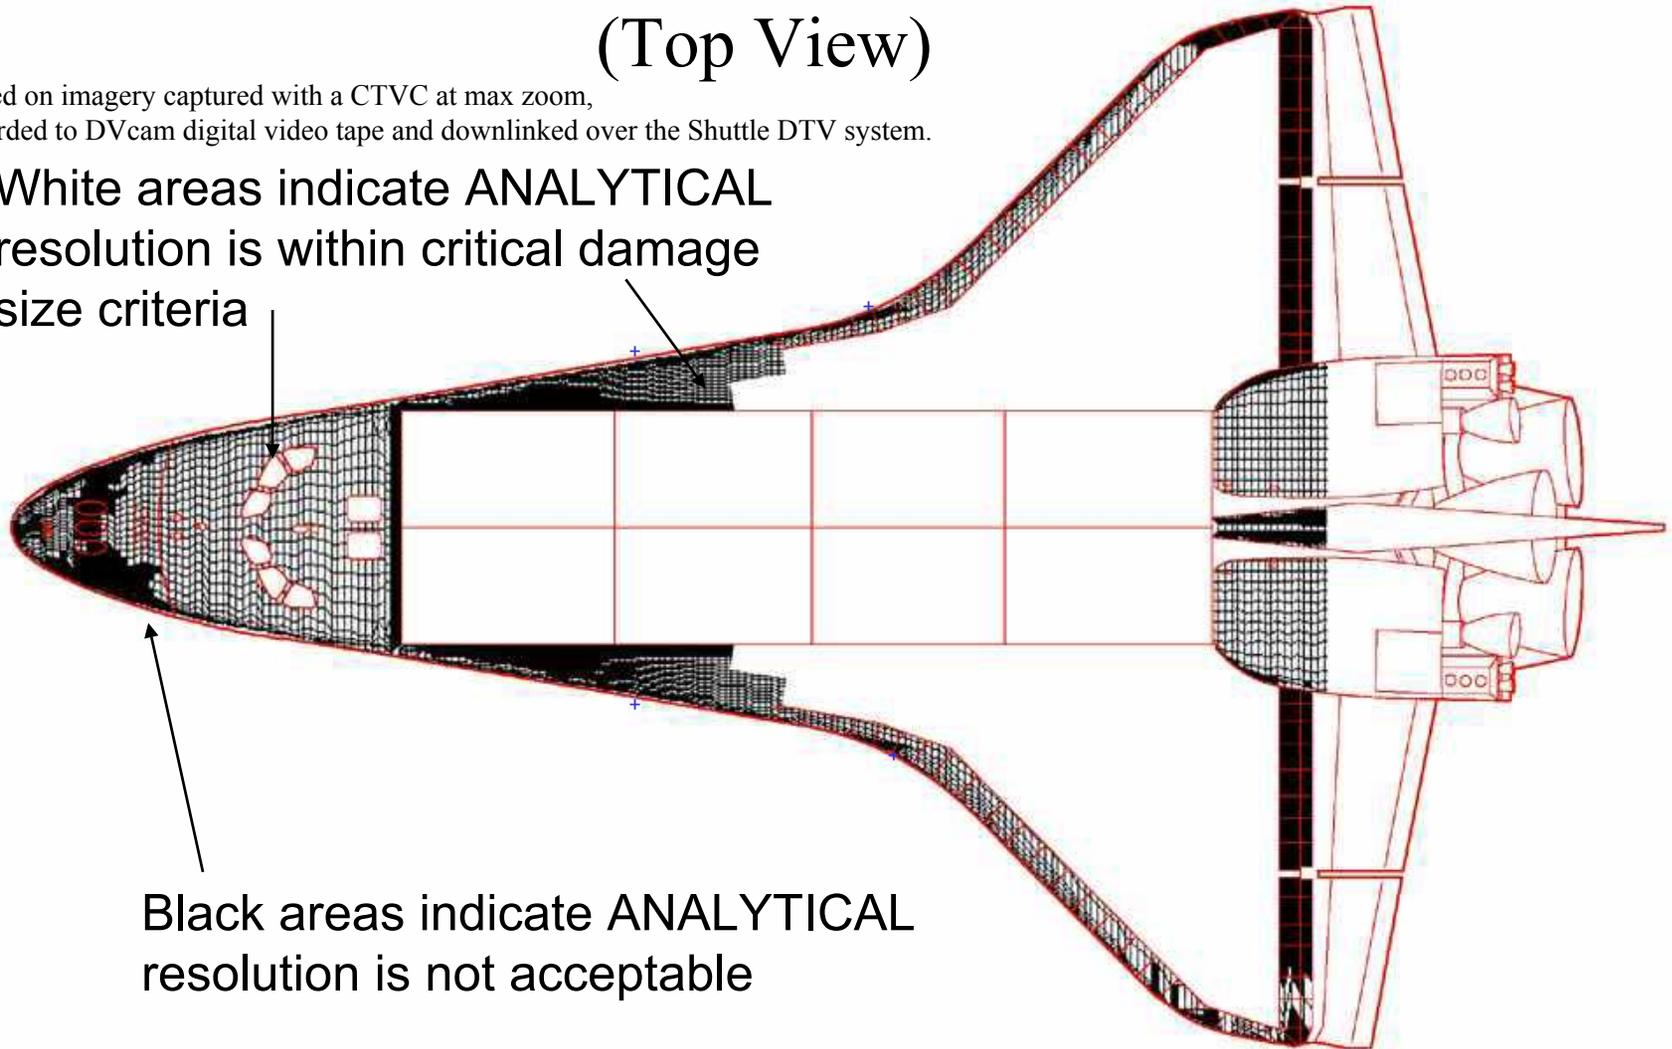
Based on imagery captured with a CTVC at max zoom,
recorded to DVcam digital video tape and downlinked over the Shuttle DTV system.

White areas indicate ANALYTICAL
resolution is within critical damage
size criteria

Black areas indicate ANALYTICAL
resolution is not acceptable

Note: Black mesh gridlines in white areas are artifacts of mapping program and are within critical damage size criteria. Area where black mesh gridlines merge on curved surface appear black. Area resolvable within critical damage size criteria.
